Last Modified: 07-05-2024	6.11:8.1.0	Doc ID: RM100000002JRHD
Model Year Start: 2024	Model: Land Cruiser	Prod Date Range: [02/2024 -]
Title: AUDIO / VIDEO: RADIO RECEIVER: REMOVAL; 2024 MY Land Cruiser [02/2024 -]

REMOVAL

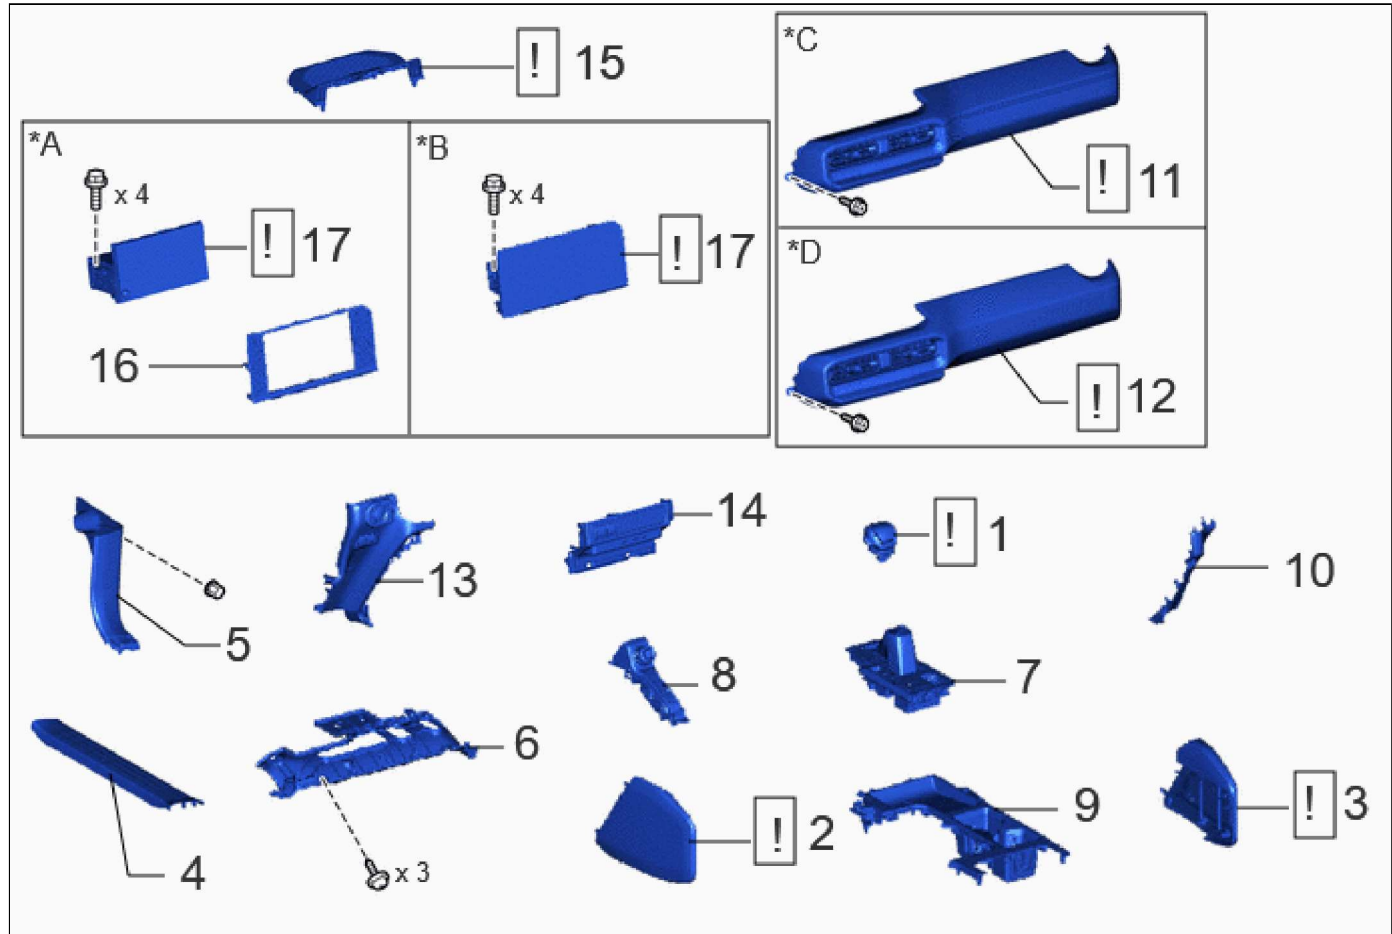
COMPONENTS (REMOVAL)

1	SHIFT LEVER KNOB SUB-ASSEMBLY	33504F	INFO	-	-
2	LOWER NO. 1 INSTRUMENT PANEL PAD SUB-ASSEMBLY	55402E	INFO	-	-
3	LOWER NO. 2 INSTRUMENT PANEL PAD SUB-ASSEMBLY	55403G	INFO	-	-
4	FRONT DOOR SCUFF PLATE LH	67914B	-	-	-
5	COWL SIDE TRIM BOARD LH	62112	-	-	-
6	NO. 1 INSTRUMENT PANEL UNDER COVER	55641	-	-	-
7	UPPER CONSOLE PANEL ASSEMBLY	-	-	-	-
8	INTEGRATION CONTROL AND PANEL SUB-ASSEMBLY	84012	-	-	-
9	UPPER CONSOLE PANEL SUB-ASSEMBLY	58804A	-	-	-
10	LOWER INSTRUMENT PANEL LH	55313	-	-	-
11	NO. 1 INSTRUMENT PANEL GARNISH SUB-ASSEMBLY	55011A	INFO	-	-
12	INSTRUMENT PANEL ORNAMENT	55461A	INFO	-	-
13	LOWER INSTRUMENT PANEL FINISH PANEL ASSEMBLY	55480D	-	-	-
14	CENTER INSTRUMENT CLUSTER FINISH PANEL SUB-ASSEMBLY	55405B	-	-	-
15	UPPER INSTRUMENT CLUSTER FINISH PANEL	55421B	INFO	-	-
16	CENTER INSTRUMENT CLUSTER FINISH PANEL	55412D	-	-	-
17	RADIO AND DISPLAY RECEIVER ASSEMBLY WITH BRACKET	-	INFO	-	-

*A	for 8 Inch Display	*B	for 12.3 Inch Display
*C	for Type A	*D	for Type B

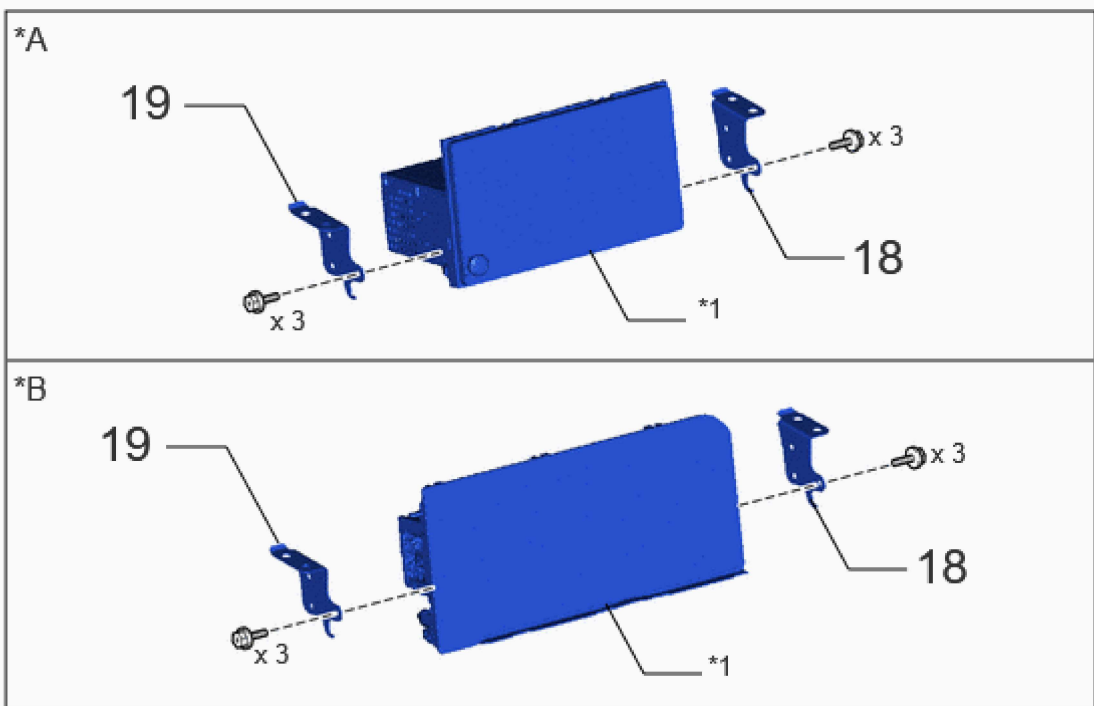
18	NO. 1 RADIO RECEIVER BRACKET	86211J	-	-	-
19	NO. 2 RADIO RECEIVER BRACKET	86212C	-	-	-

*A	for 8 Inch Display	*B	for 12.3 Inch Display
*1	RADIO AND DISPLAY RECEIVER ASSEMBLY	-	-

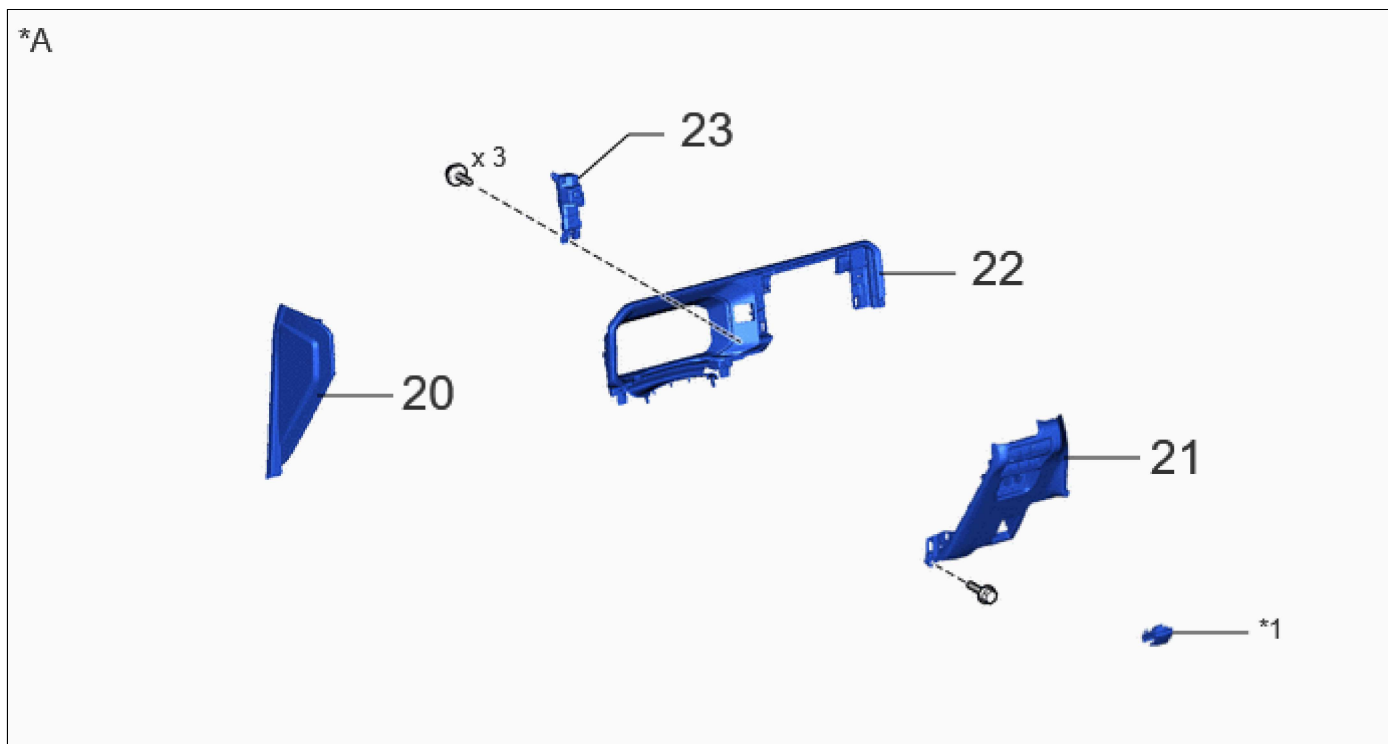
20	INSTRUMENT SIDE PANEL LH	55318C	-	-	-
21	LOWER INSTRUMENT PANEL FINISH PANEL SUB-ASSEMBLY	55045	-	-	-
22	CENTER INSTRUMENT CLUSTER FINISH PANEL ASSEMBLY	55420A	-	-	-
23	SWITCH AND VOLUME ASSEMBLY	86170A	-	-	-

*A	for 12.3 Inch Display	-	-
*1	HOOD LOCK CONTROL LEVER SUB-ASSEMBLY	-	-

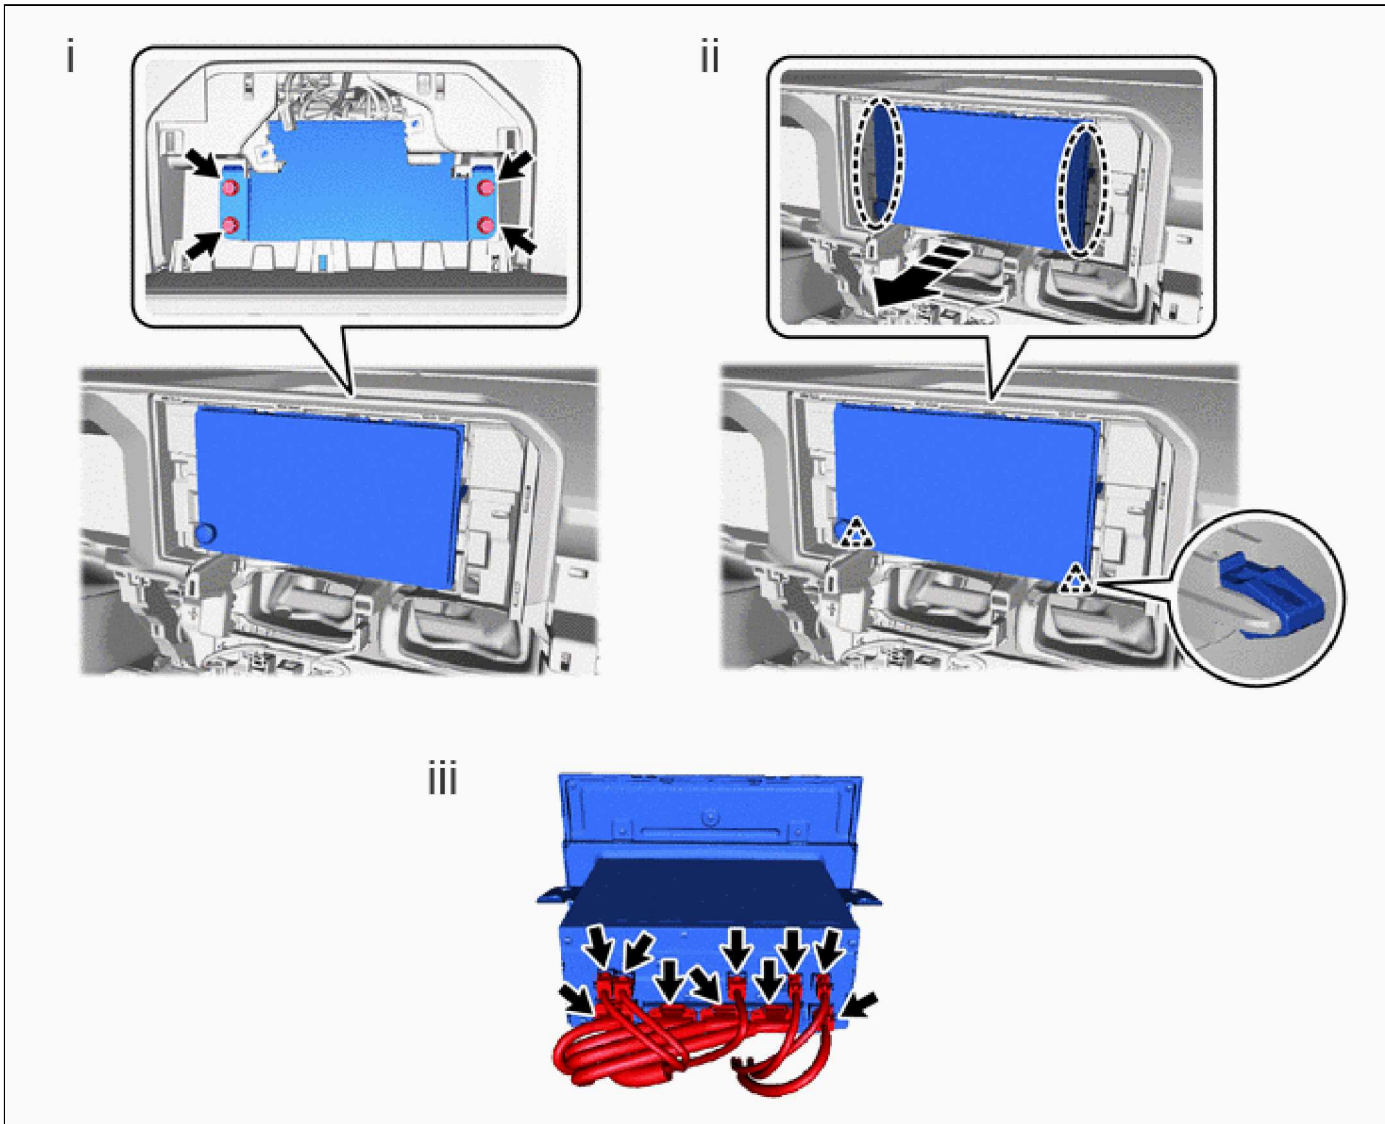
(a) for 8 Inch Display:

Place Hands Here

Remove in this Direction
---	------------------	---	--------------------------

(1) Remove the 4 bolts.

(2) Place your hands shown in the illustration and move it toward the rear of the vehicle to detach the clip.

(3) Disconnect each connector.

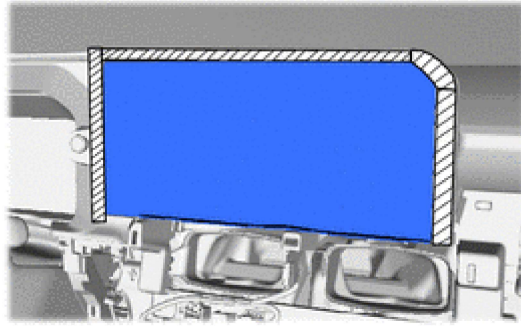
(b) for 12.3 Inch Display:

Protective tape

(1) Put protective tape around the radio and display receiver assembly with bracket.

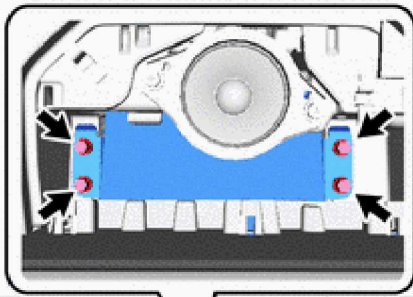
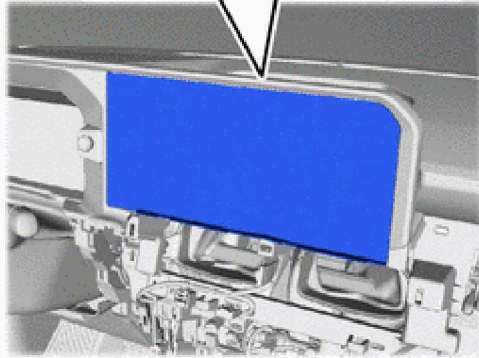
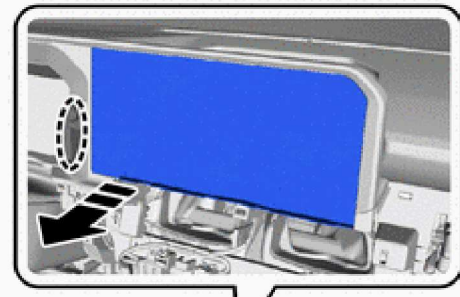
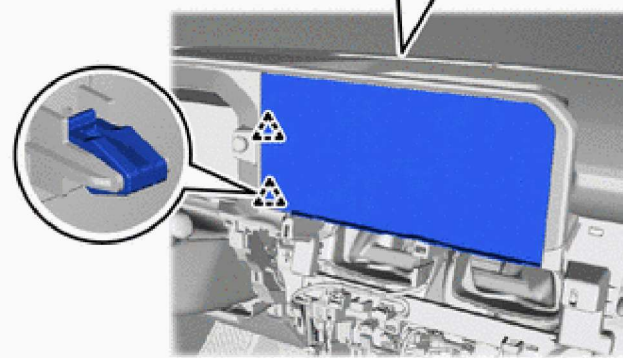
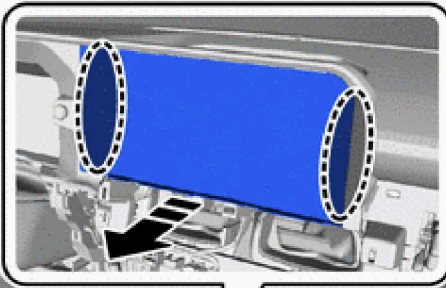
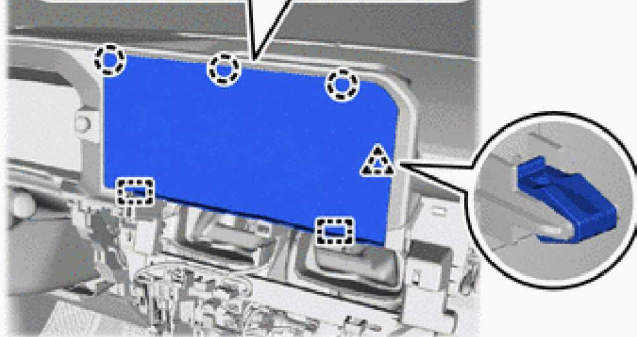
(c) for 12.3 Inch Display:

Place Hands Here

Remove in this Direction

- (1) Remove the 4 bolts.
- (2) While holding the position shown in the figure, detach the clip.
- (3) Place your hands shown in the illustration and move it toward the rear of the vehicle to detach the clip, claw and guide.
- (4) Disconnect each connector.

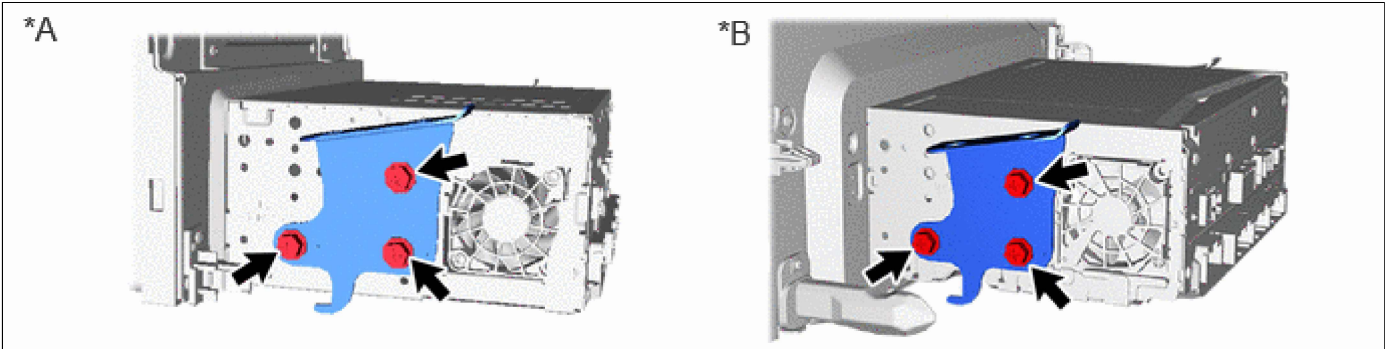
18. REMOVE NO. 1 RADIO RECEIVER BRACKET

*A	for 8 Inch Display	*B	for 12.3 Inch Display
----	--------------------	----	-----------------------

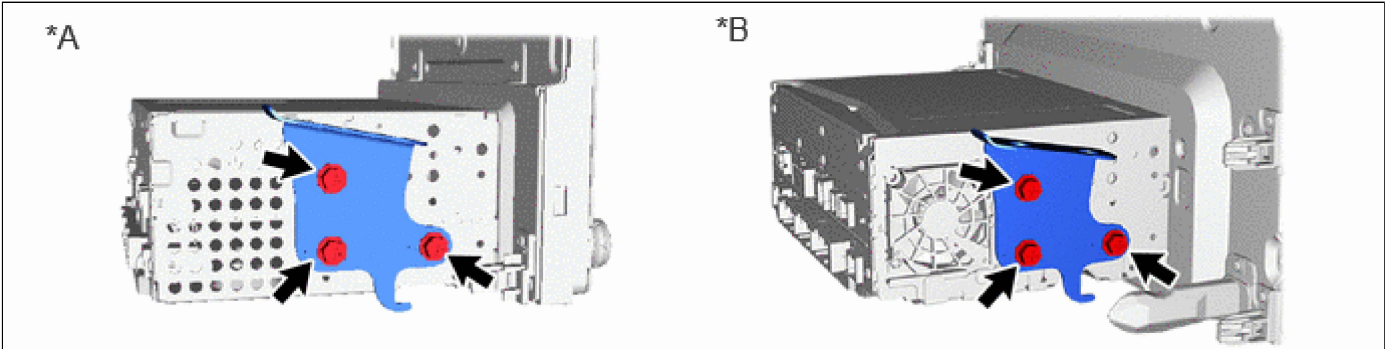
19. REMOVE NO. 2 RADIO RECEIVER BRACKET

*A	for 8 Inch Display	*B	for 12.3 Inch Display
----	--------------------	----	-----------------------

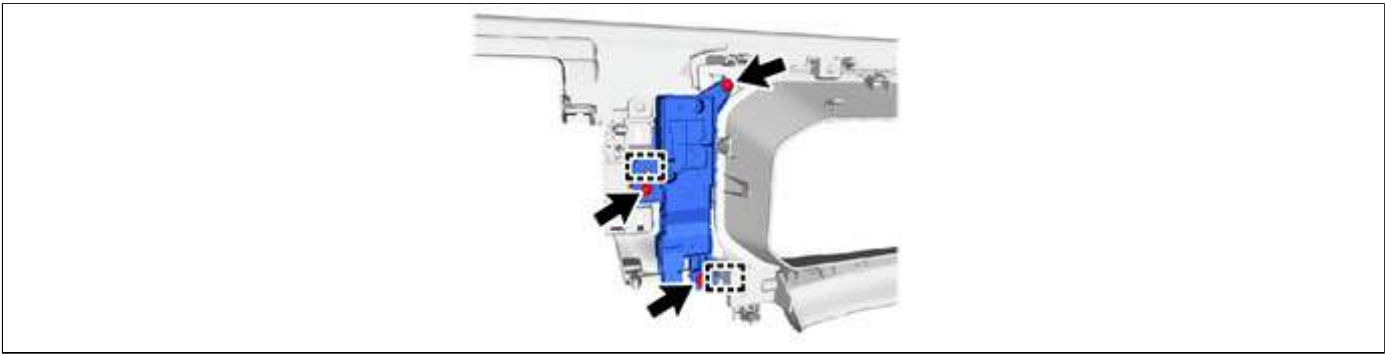
23. REMOVE SWITCH AND VOLUME ASSEMBLY (for 12.3 Inch Display)

HINT:
Perform this procedure only when replacing the switch and volume assembly.
