Last Modified: 07-05-2024	6.11:8.1.0	Doc ID: RM100000002K9IU
Model Year Start: 2024	Model: Land Cruiser	Prod Date Range: [02/2024 -]
Title: EXTERIOR PANELS / TRIM: BACK DOOR OUTSIDE GARNISH: REMOVAL; 2024 MY Land Cruiser [02/2024 -]

REMOVAL

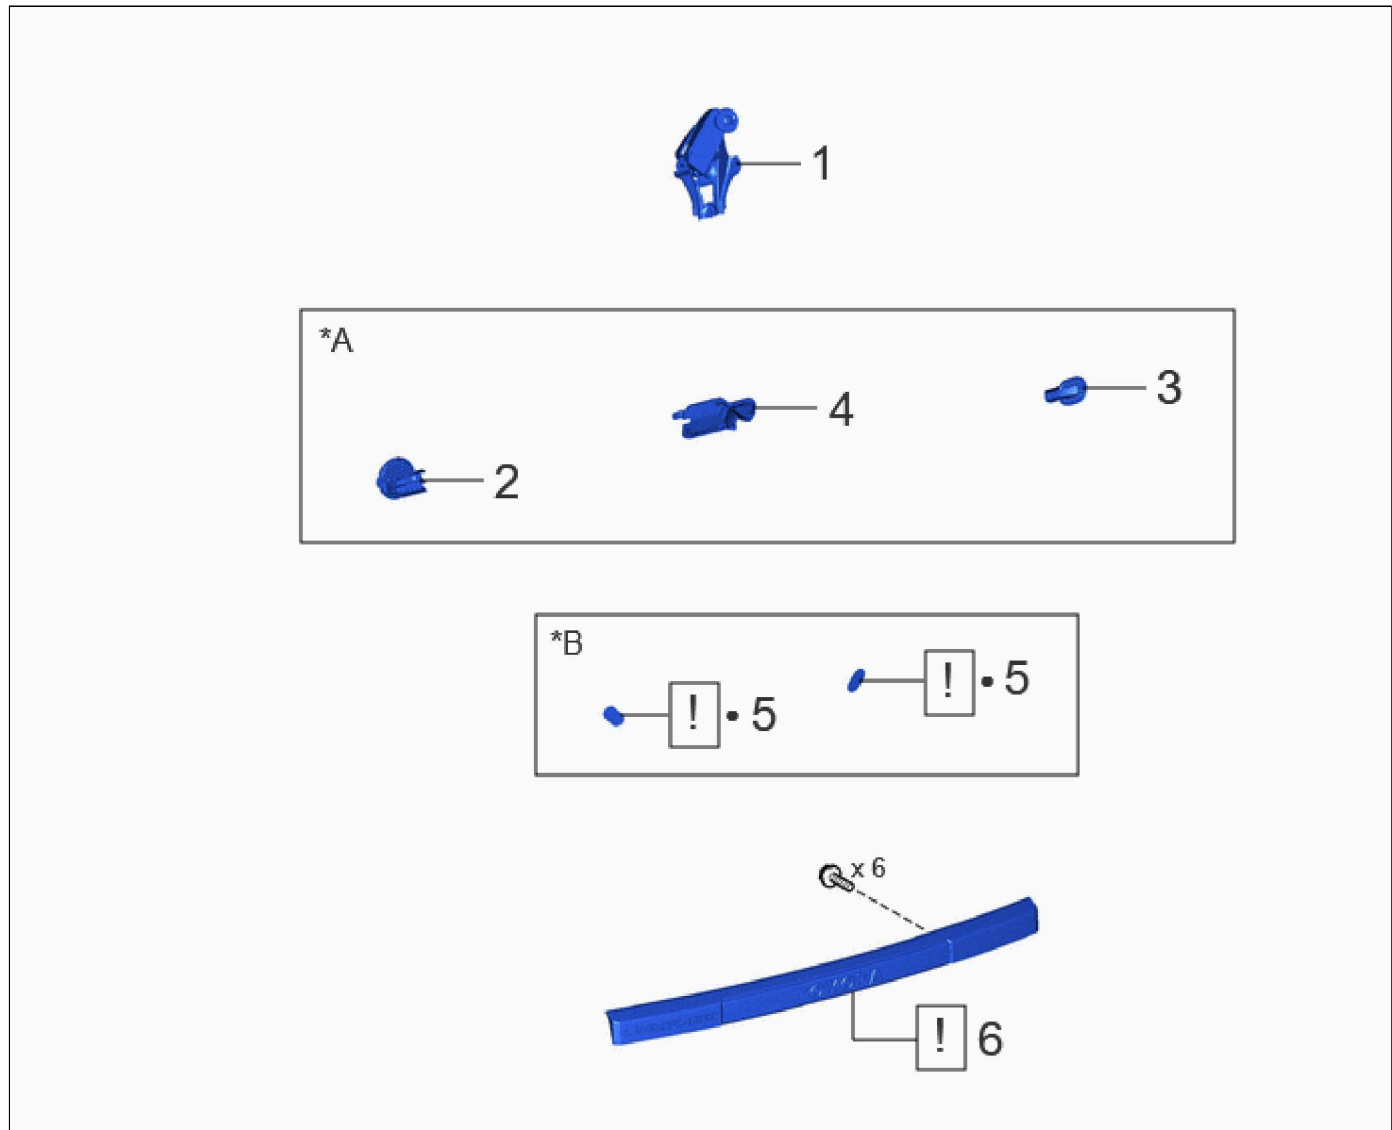
COMPONENTS (REMOVAL)

1	REAR WIPER MOTOR ASSEMBLY	85110R	-	-	-
2	BACK DOOR NO. 4 SERVICE HOLE COVER	67768C	-	-	-

3	BACK DOOR NO. 3 SERVICE HOLE COVER	67767B	-	-	-
4	BACK DOOR NO. 1 SERVICE HOLE COVER	67765A	-	-	-
5	OUTER MIRROR PROTECTOR	-	INFO	-	-
6	BACK DOOR OUTSIDE GARNISH SUB-ASSEMBLY	76801	INFO	-	-

*A	w/ Cover	*B	w/ Back Door Speaker
•	Non-reusable part	-	-

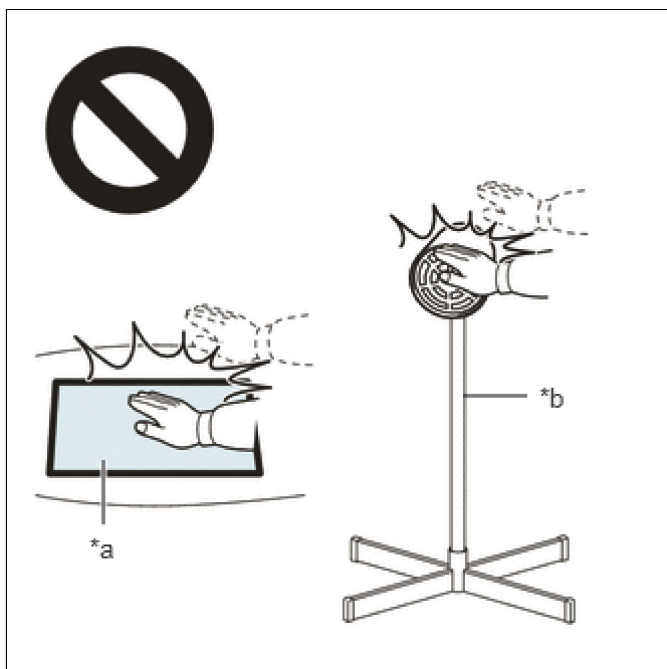
<p>NOTICE:</p> <p>When removing the outer mirror protector, if the double-sided tape is difficult to remove, heat the adhesive of the outer mirror protector using a heat light.</p>
---	---

PART	TEMPERATURE
Outer Mirror Protector	20 to 30°C (68 to 86°F)

- Do not touch the heat light and heated parts.
- Touching the heat light may result in burns.
- Touching heated parts for a long time may result in burns.

*a	Heated Part
*b	Heat Light

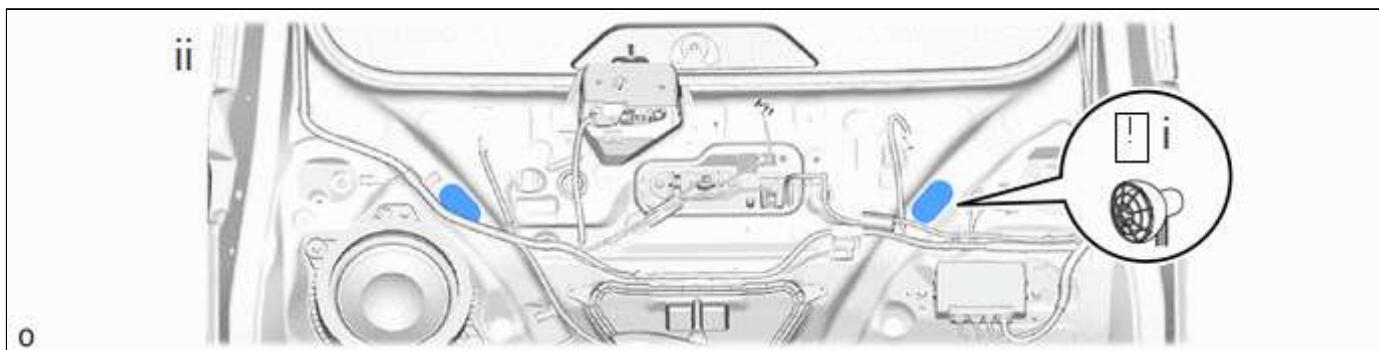
Do not heat the outer mirror protector excessively.

- (1) Heat the adhesive of the outer mirror protector using a heat light.
- (2) Remove the 2 outer mirror protectors.

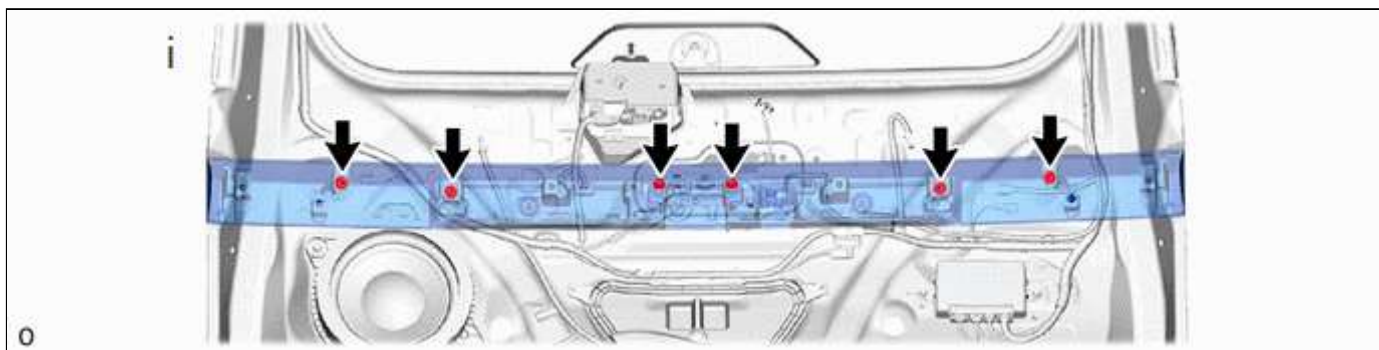
- (1) Remove the 6 bolts.

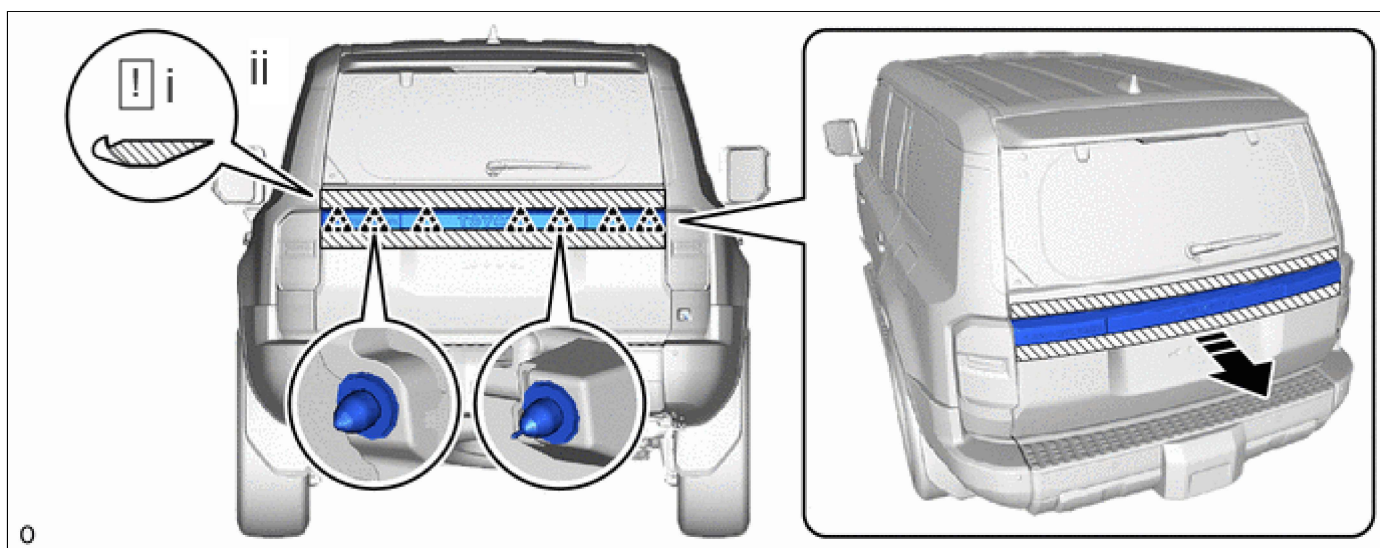
Remove in this Direction	-	-
---	--------------------------	---	---

(1) Put protective tape around the back door outside garnish sub-assembly.

(2) Detach the clip and remove the back door outside garnish sub-assembly as shown in the illustration.
