3	INNER REAR VIEW MIRROR ASSEMBLY	87810	<a href="#">INFO</a>	-	-

### **3. REMOVE INNER REAR VIEW MIRROR ASSEMBLY**

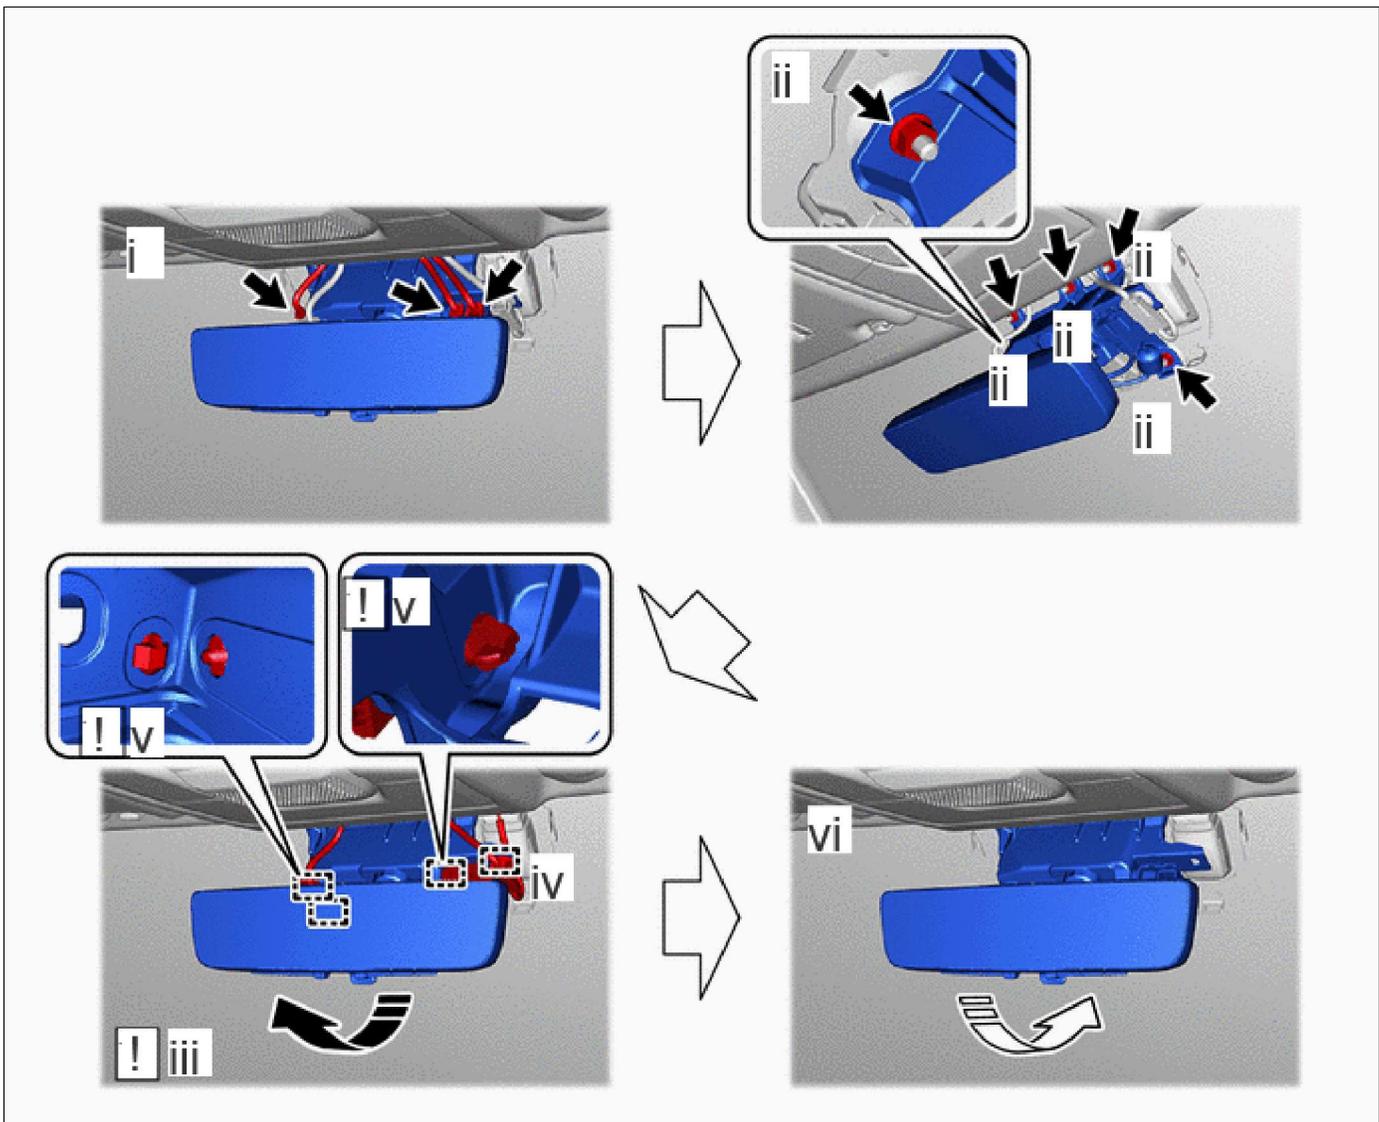
Lift in this Direction		Temporarily attachment in this Direction
--	------------------------	--	--

- (1) Disconnect the 3 connectors shown in this illustration.
- (2) Remove the 5 nuts.
- (3) Lift the Inner rear view mirror assembly with bracket in the direction shown in this illustration.

- The upper part of the inner rear view mirror assembly with bracket is not completely removed because the roof headlining interferes with inner rear view mirror assembly with bracket.
- Forcibly removing the inner rear view mirror assembly with bracket or lifting it with more force than necessary will cause damage to inner rear view mirror assembly and roof headlining assembly.

- (4) Detach the clamp shown in this illustration.
- (5) Detach the each clamp shown in this illustration.

Perform this work from the windshield side. if you do it from the connector mounting side, there is a risk of damage.

- (6) Return the inner rear view mirror assembly with bracket to the installation position and temporarily attach it.

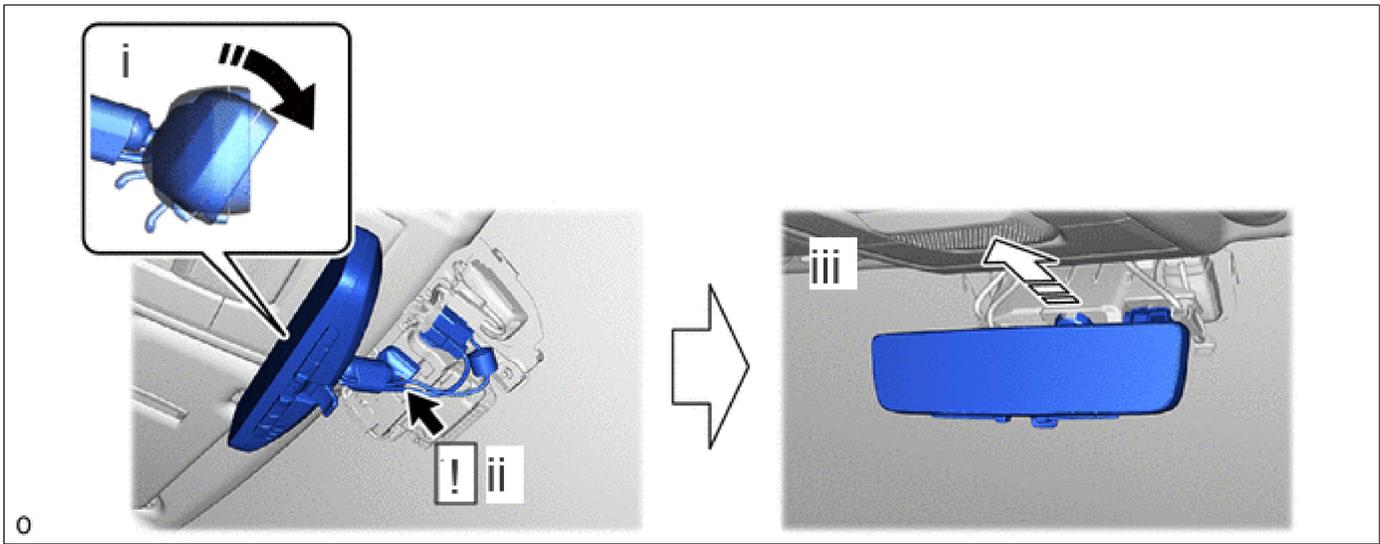
Tilt in this Direction

Remove in this Direction
---	------------------------	---	--------------------------

- (1) Tilt the mirror surface down to the maximum tiltable position.
- (2) Using a T20 "TORX" socket wrench, remove the screw.
- (3) Slide the inner rear view mirror assembly as shown in the illustration and remove the inner rear view mirror assembly.
