Last Modified: 07-05-2024	6.11:8.1.0	Doc ID: RM100000002K9H1
Model Year Start: 2024	Model: Land Cruiser	Prod Date Range: [02/2024 -]
Title: EXTERIOR PANELS / TRIM: FRONT BUMPER: INSTALLATION; 2024 MY Land Cruiser [02/2024 -]

INSTALLATION

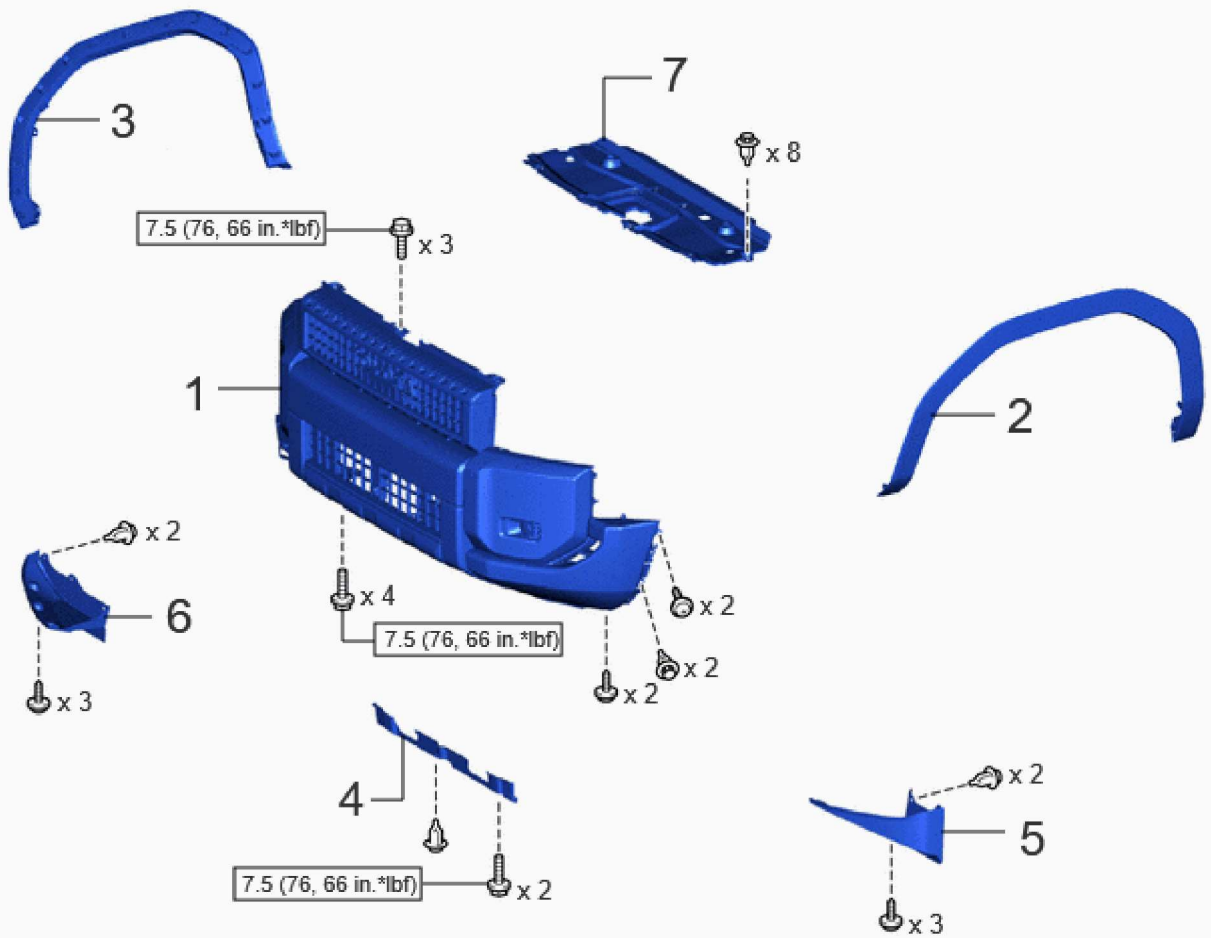
COMPONENTS (INSTALLATION)

8 (*A), 9 (*B), 10 —

*A	w/ Panoramic View Monitor System	*B	w/ Fog Light
