<b>Last Modified:</b> 07-05-2024	6.11:8.1.0	<b>Doc ID:</b> RM100000002JQ90
<b>Model Year Start:</b> 2024	<b>Model:</b> Land Cruiser	<b>Prod Date Range:</b> [02/2024 -     ]
<b>Title:</b> INTERIOR PANELS / TRIM: FRONT CONSOLE BOX (w/o Cool Box): REMOVAL; 2024 MY Land Cruiser [02/2024 -     ]

## REMOVAL

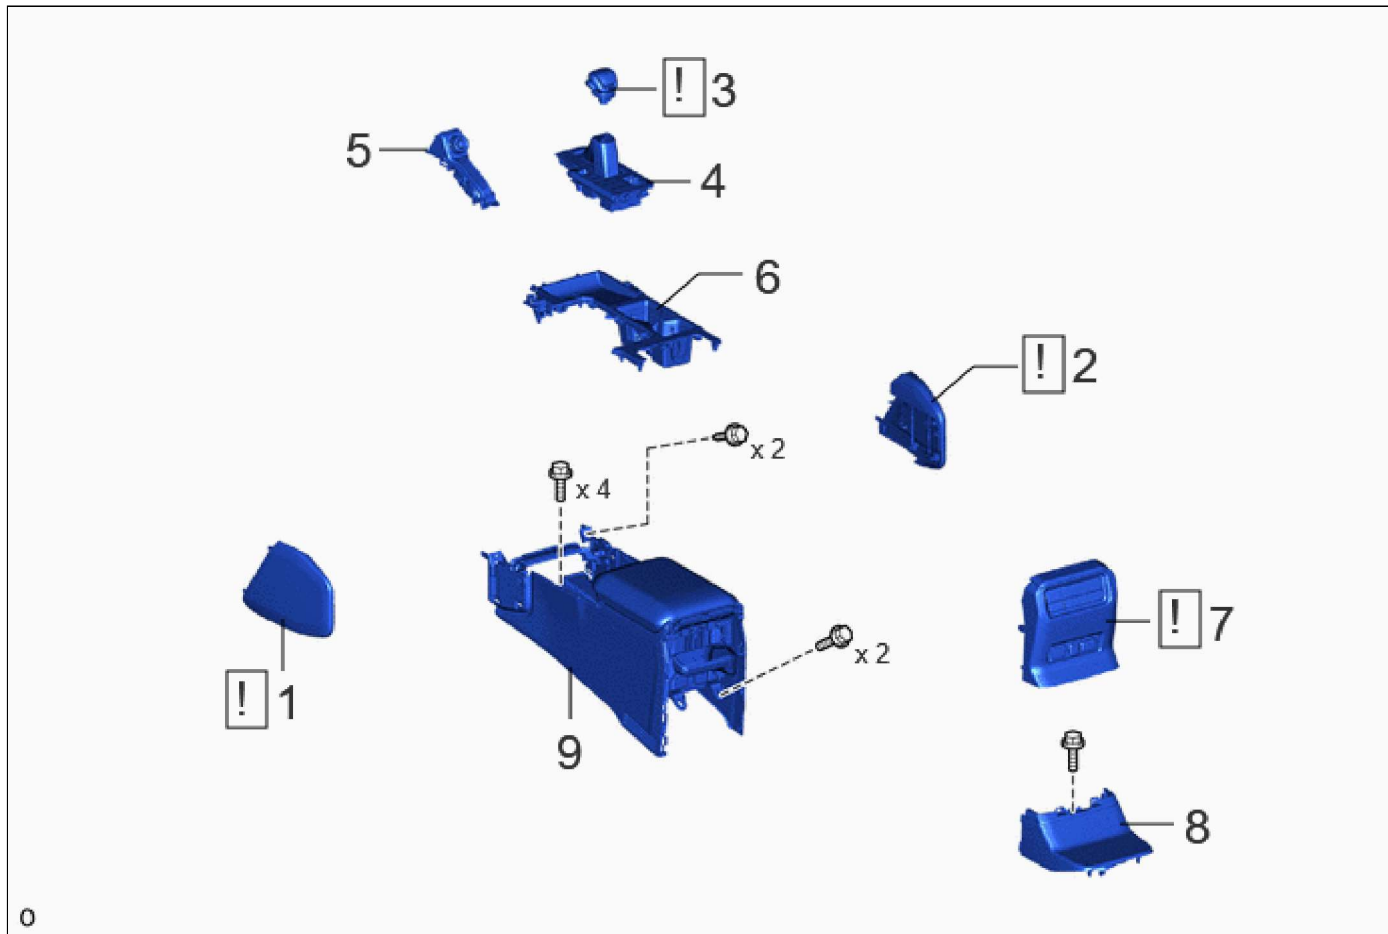
### COMPONENTS (REMOVAL)

1	LOWER NO. 1 INSTRUMENT PANEL PAD SUB-ASSEMBLY	55402E	<a href="#">INFO</a>	-	-
2	LOWER NO. 2 INSTRUMENT PANEL PAD SUB-ASSEMBLY	55403G	<a href="#">INFO</a>	-	-
3	SHIFT LEVER KNOB SUB-ASSEMBLY	33504F	<a href="#">INFO</a>	-	-
4	UPPER CONSOLE PANEL ASSEMBLY	-	-	-	-
5	INTEGRATION CONTROL AND PANEL SUB-ASSEMBLY	84012	-	-	-
6	UPPER CONSOLE PANEL SUB-ASSEMBLY	58804A	-	-	-

7	CONSOLE REAR END PANEL SUB-ASSEMBLY	58903A

-	-
8	NO. 2 CONSOLE REAR END PANEL SUB-ASSEMBLY	58904C	-	-	-
9	CONSOLE BOX ASSEMBLY	-	-	-	-

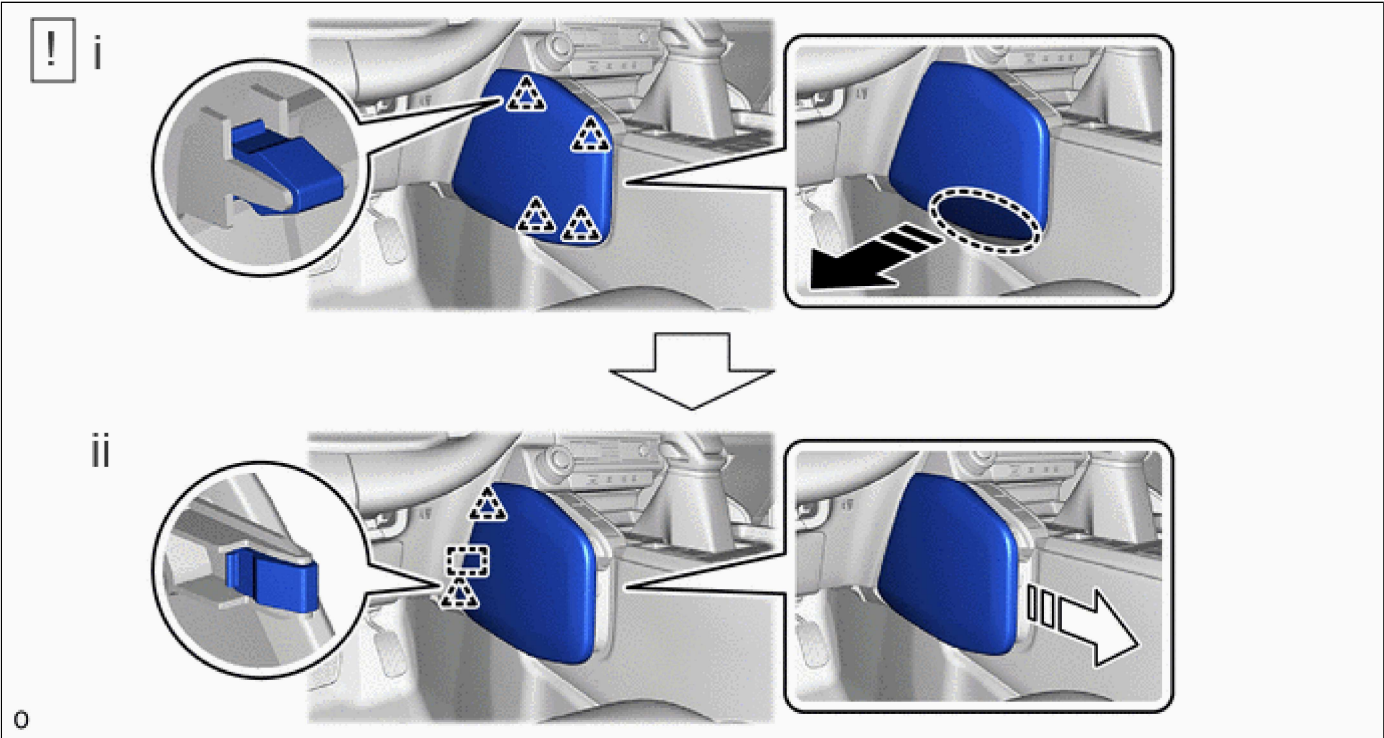
1. REMOVE LOWER NO. 1 INSTRUMENT PANEL PAD SUB-ASSEMBLY

- (1) Place your hand as shown in the illustration, detach the clip.
- (2) Detach the clip and guide and remove the lower No. 1 instrument panel pad sub-assembly.

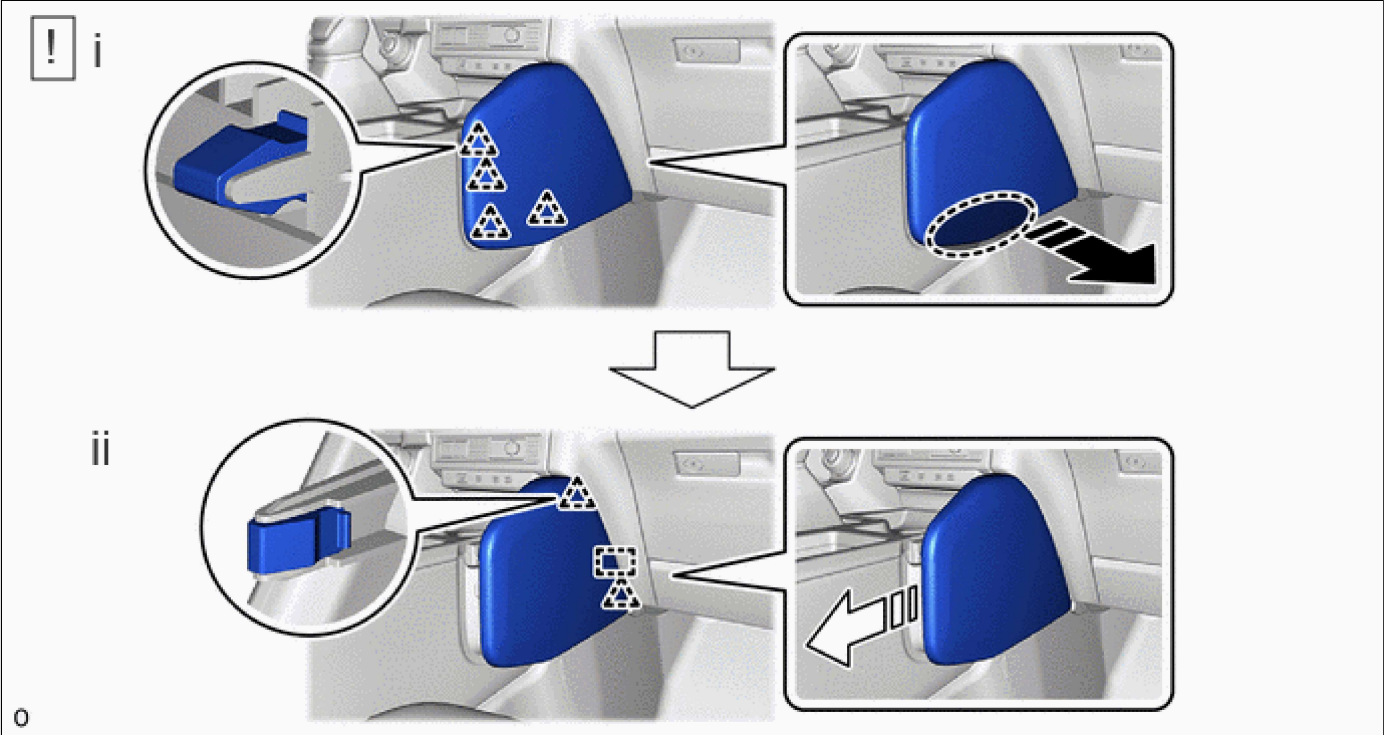
2. REMOVE LOWER NO. 2 INSTRUMENT PANEL PAD SUB-ASSEMBLY

- (1) Place your hand as shown in the illustration, detach the clip.
- (2) Detach the clip and guide and remove the lower No. 2 instrument panel pad sub-assembly.

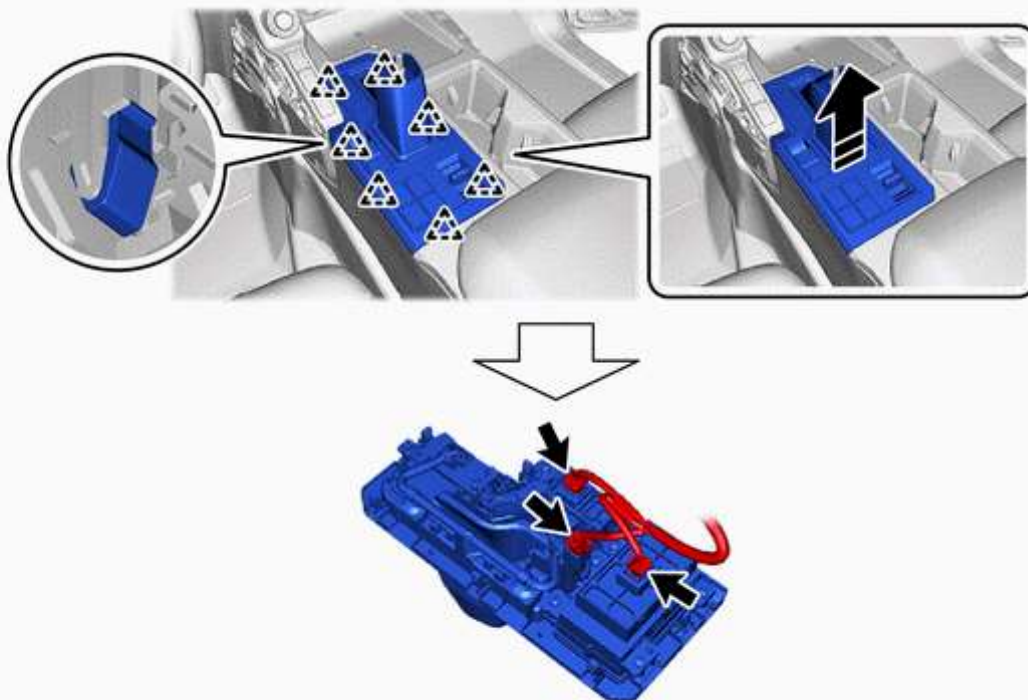
4. REMOVE UPPER CONSOLE PANEL ASSEMBLY

Remove in this Direction	-	-
---	--------------------------	---	---

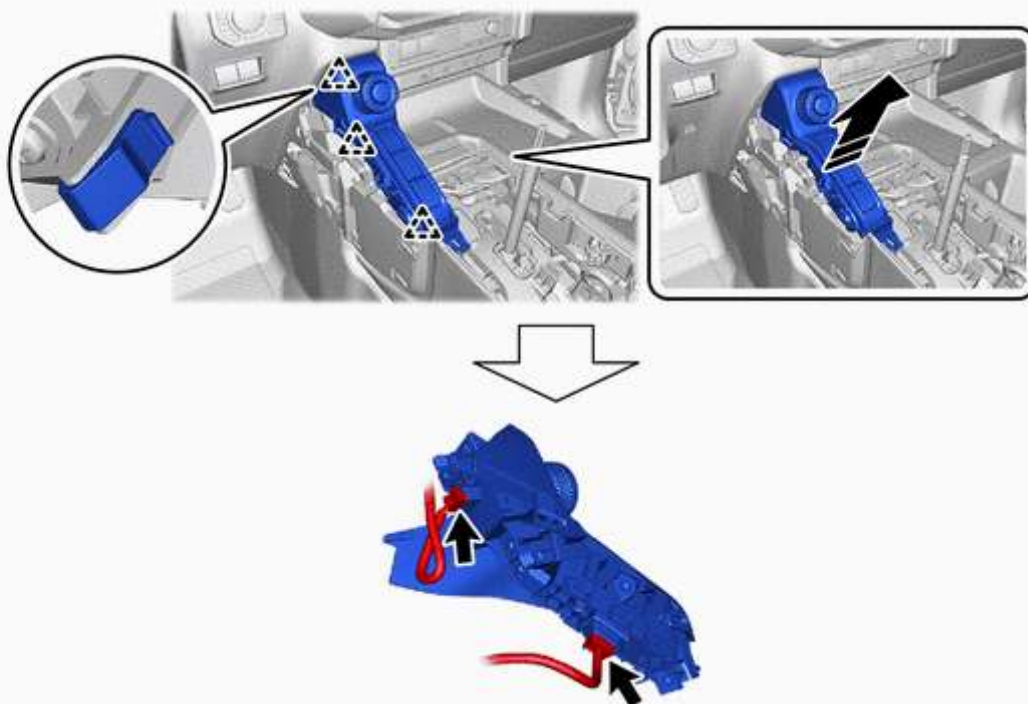
## 5. REMOVE INTEGRATION CONTROL AND PANEL SUB-ASSEMBLY

Remove in this Direction	-	-
---	--------------------------	---	---

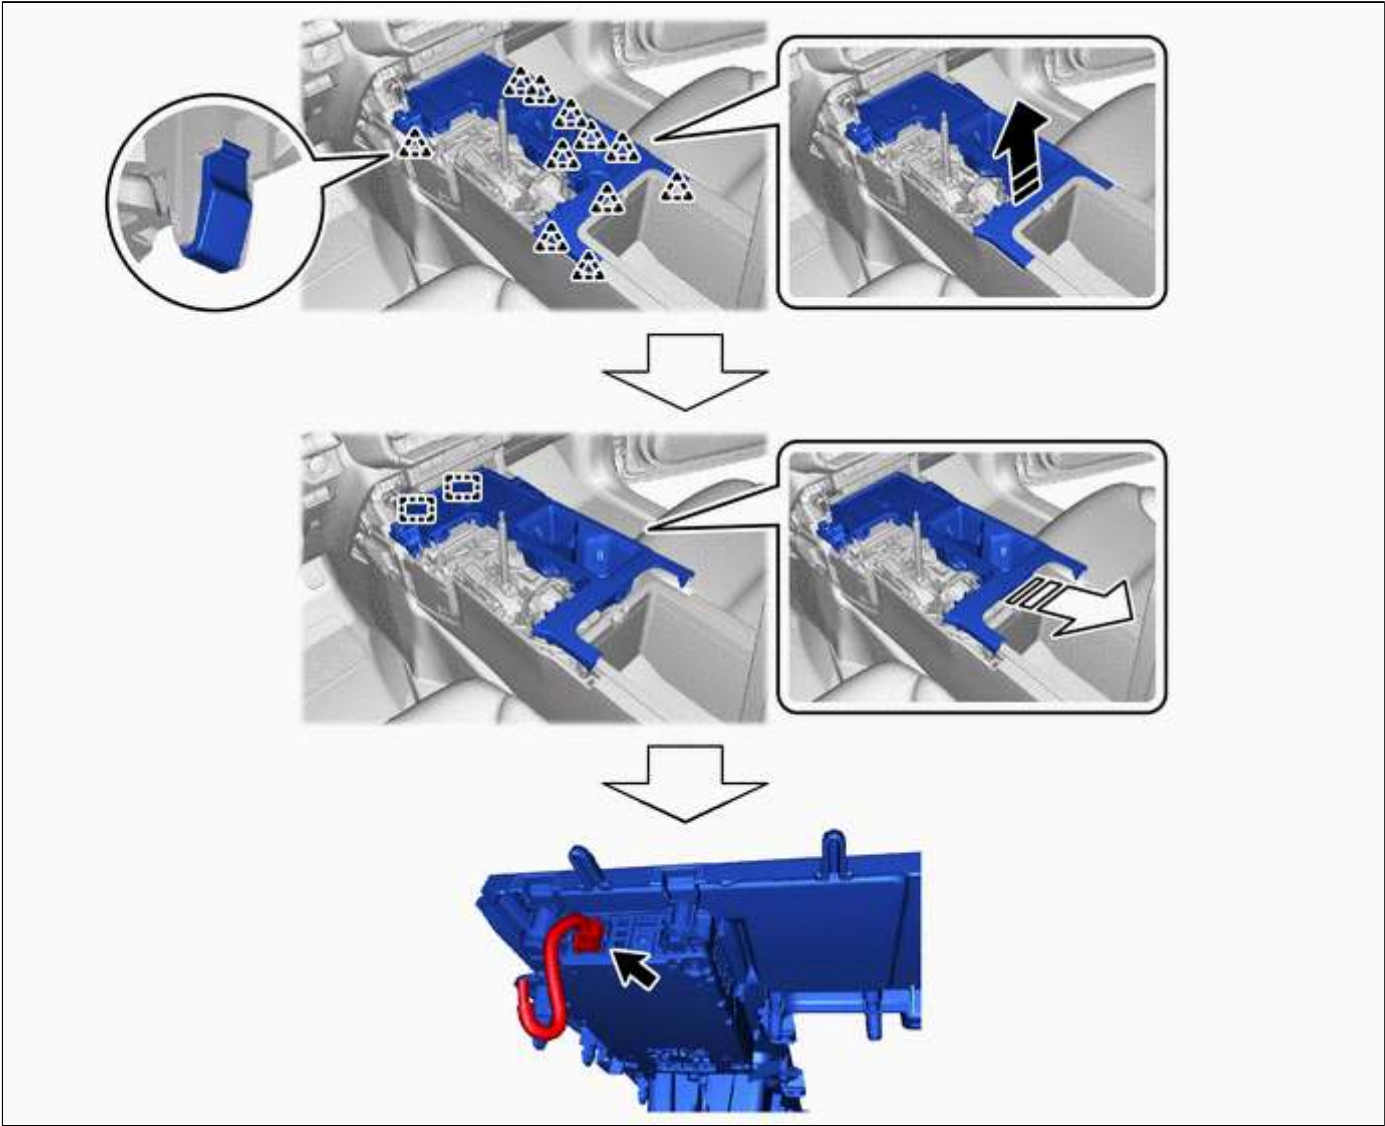
## 6. REMOVE UPPER CONSOLE PANEL SUB-ASSEMBLY

Remove in this Direction (1)

Remove in this Direction (2)
---	------------------------------	---	------------------------------

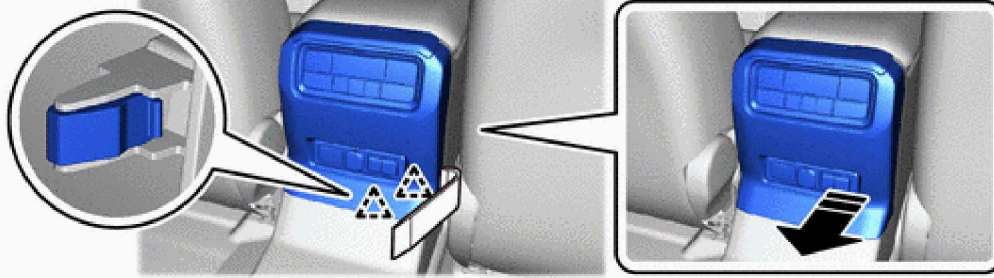
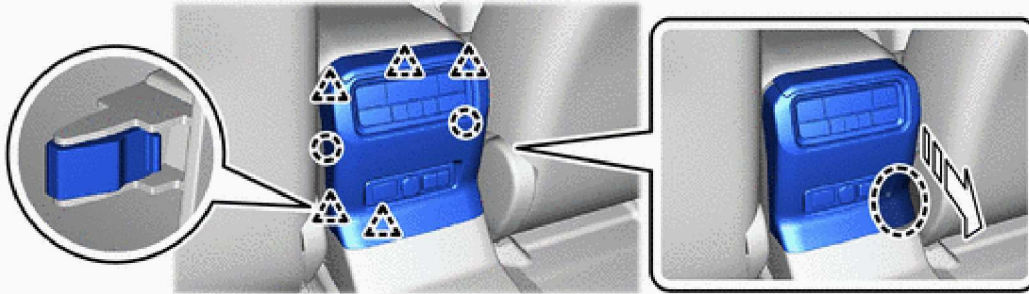
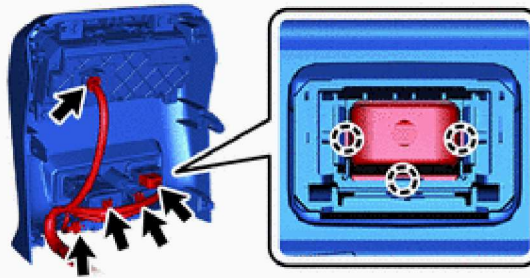
**7. REMOVE CONSOLE REAR END PANEL SUB-ASSEMBLY**

- (1) Insert moulding remover D in the position shown in the illustration.
- (2) Place your hand in the gap as shown in the illustration, detach the clip.
- (3) Place your hand as shown in the illustration, detach the claw and clip and remove the rear console end panel sub-assembly.
- (4) Disconnect the each connectors and detach the claw.

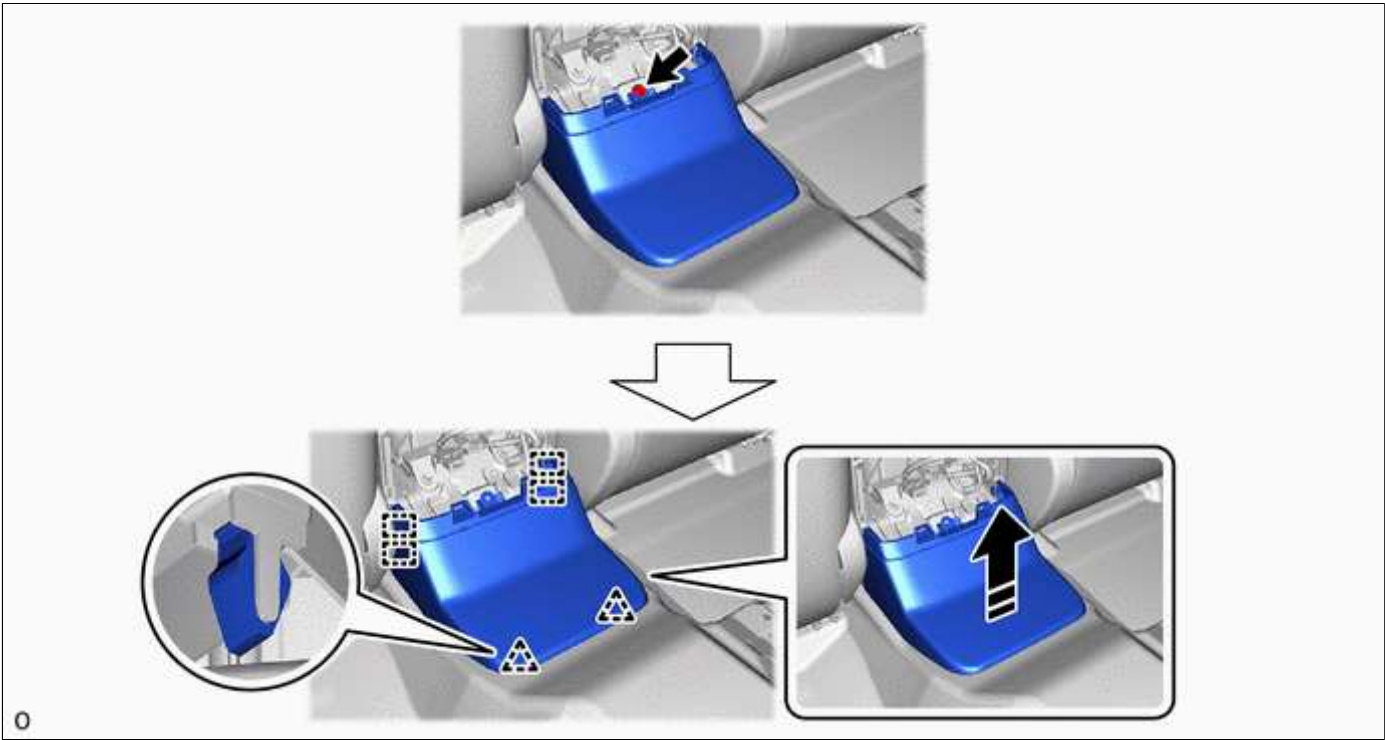
## 8. REMOVE NO. 2 CONSOLE REAR END PANEL SUB-ASSEMBLY

Remove in this Direction	-	-
--	--------------------------	---	---

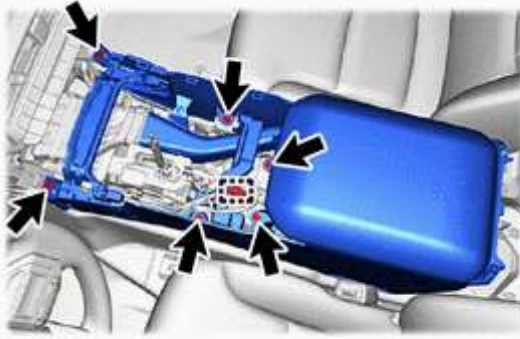
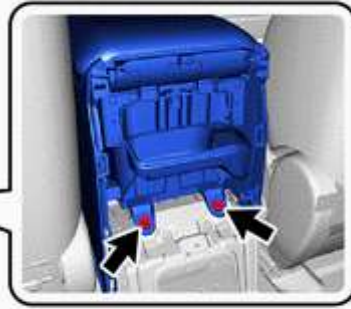
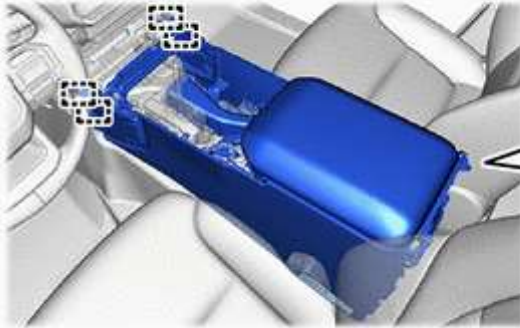
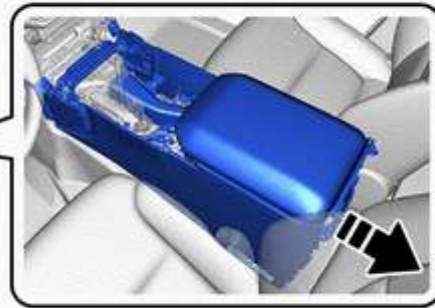
9. REMOVE CONSOLE BOX ASSEMBLY

Remove in this Direction
