Last Modified: 07-05-2024	6.11:8.1.0	Doc ID: RM100000002JUXP
Model Year Start: 2024	Model: Land Cruiser	Prod Date Range: [02/2024 -]
Title: INTERIOR PANELS / TRIM: FLOOR CARPET: REMOVAL; 2024 MY Land Cruiser [02/2024 -]

COMPONENTS (REMOVAL)

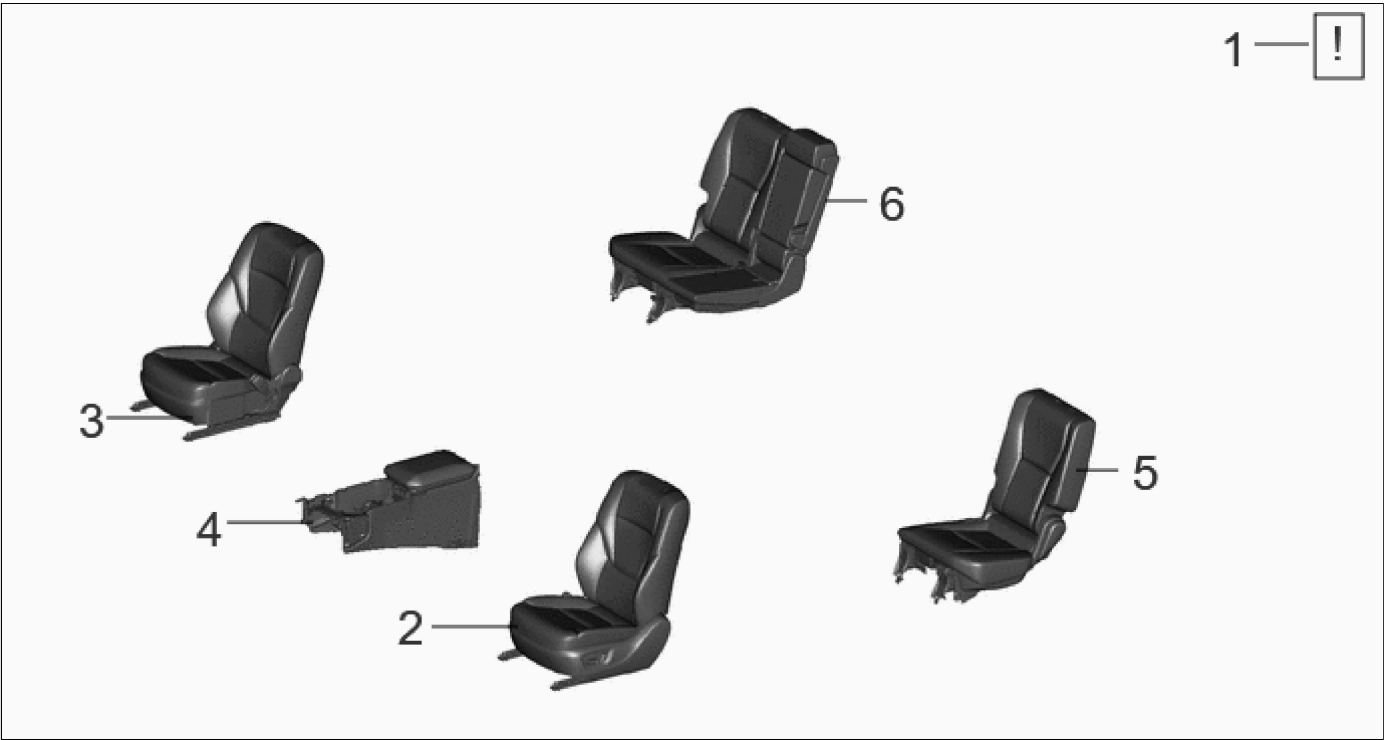
PROCEDURE		PART NAME CODE

1	PRECAUTION	-	INFO	-	-
2	FRONT SEAT ASSEMBLY LH	-	-	-	-
3	FRONT SEAT ASSEMBLY RH	-	-	-	-
4	FRONT CONSOLE BOX	-	-	-	-
5	REAR NO. 1 SEAT ASSEMBLY LH	-	-	-	-
6	REAR NO. 1 SEAT ASSEMBLY RH	-	-	-	-

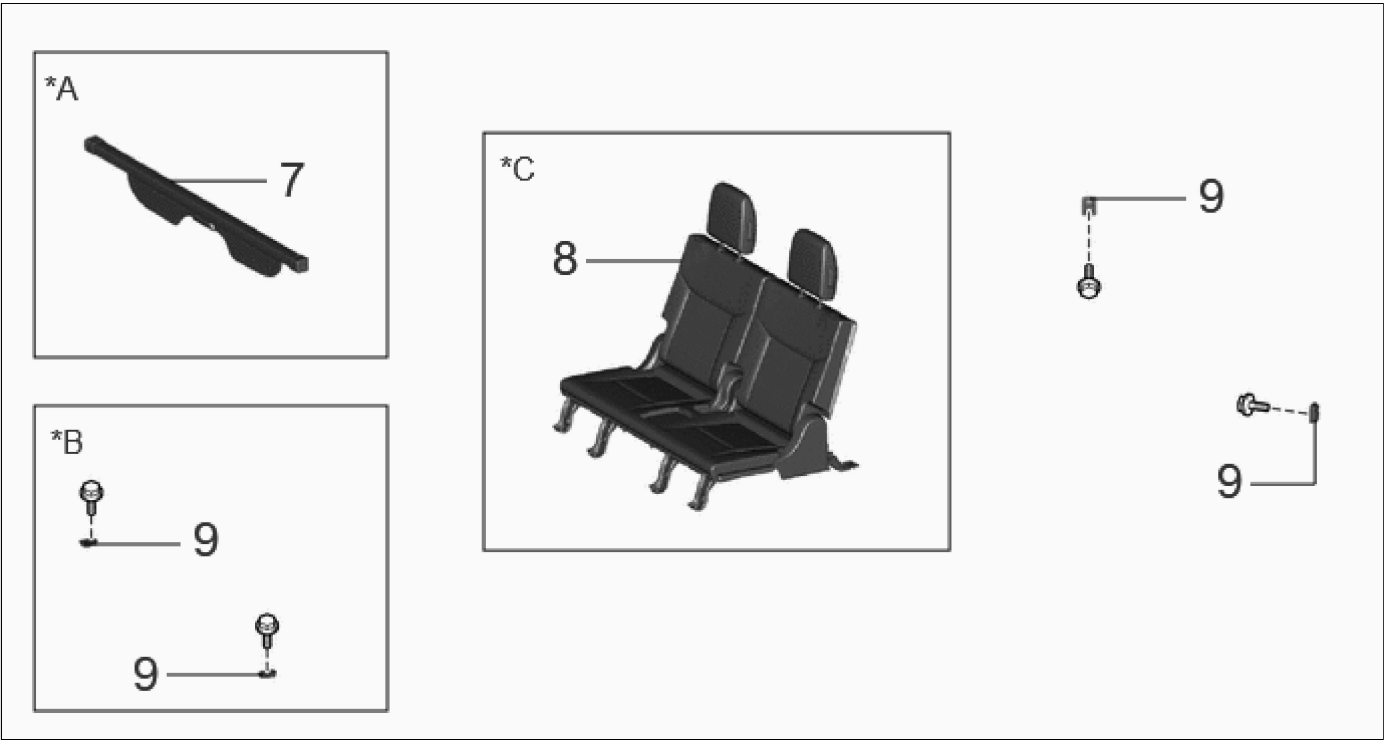
PROCEDURE		PART NAME CODE			
7	TONNEAU COVER ASSEMBLY	64910N	-	-	-
8	REAR NO. 2 SEAT ASSEMBLY	-	-	-	-
9	ROPE HOOK ASSEMBLY	-	-	-	-

*A	w/ Tonneau Cover	*B	w/o Rear No. 2 Seat
*C	w/ Rear No. 2 Seat	-	-

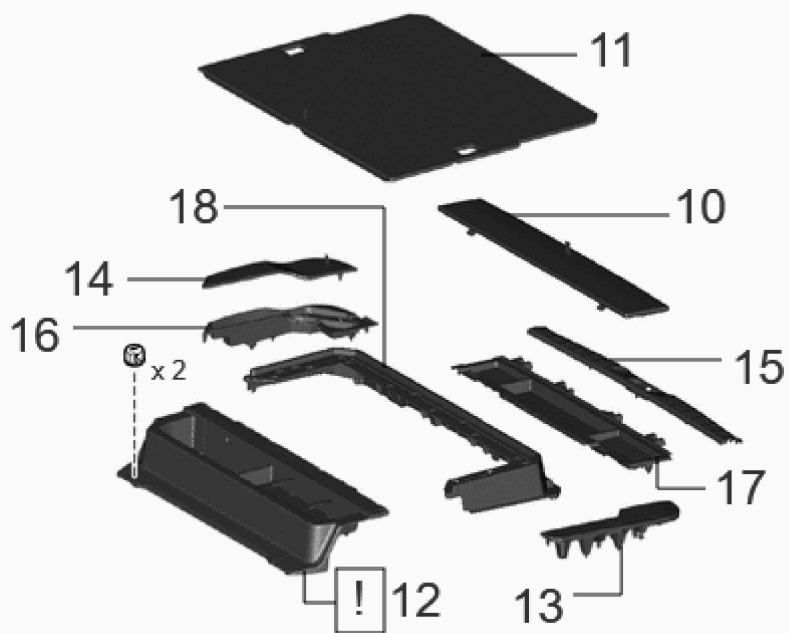
PROCEDURE		PART NAME CODE			
10	DECK BOARD ASSEMBLY	58410B	-	-	-
11	DECK BOARD ASSEMBLY	58410B	-	-	-
12	REAR DECK FLOOR BOX	64993	INFO	-	-
13	REAR FLOOR BOARD REAR LH	58418H	-	-	-
14	REAR FLOOR BOARD REAR RH	58417B	-	-	-
15	REAR FLOOR REAR MAT SUPPORT PLATE	58574A	-	-	-
16	DECK SIDE TRIM BOX RH	64741B	-	-	-
17	REAR DECK FLOOR BOX	64993	-	-	-
18	REAR NO. 1 FLOOR BOARD ASSEMBLY	58470E	-	-	-

*A	w/o Rear No. 2 Seat	-	-
----	---------------------	---	---

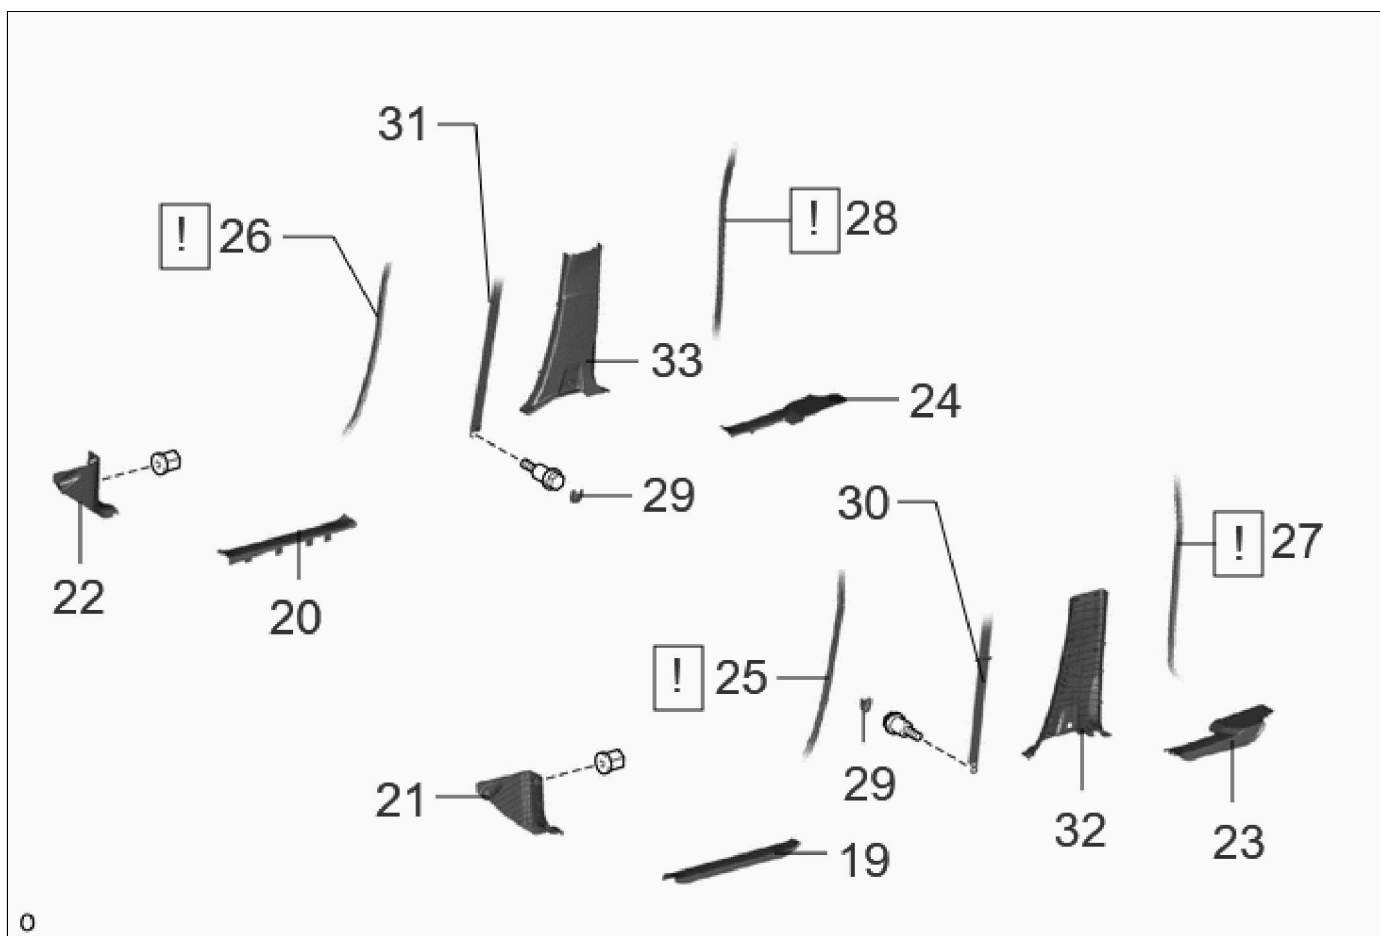
19	FRONT DOOR SCUFF PLATE LH	67914B	-	-	-
20	FRONT DOOR SCUFF PLATE RH	67913B	-	-	-
21	COWL SIDE TRIM BOARD LH	62112	-	-	-
22	COWL SIDE TRIM BOARD RH	62111C	-	-	-
23	REAR DOOR SCUFF PLATE LH	67918E	-	-	-
24	REAR DOOR SCUFF PLATE RH	67917C	-	-	-
25	FRONT DOOR OPENING TRIM WEATHERSTRIP LH	62312B	INFO	-	-
26	FRONT DOOR OPENING TRIM WEATHERSTRIP RH	62311B	INFO	-	-
27	REAR DOOR OPENING TRIM WEATHERSTRIP LH	62332C	INFO	-	-
28	REAR DOOR OPENING TRIM WEATHERSTRIP RH	62331C	INFO	-	-
29	OUTER LAP BELT ANCHOR COVER	73233	-	-	-
30	FRONT SEAT OUTER BELT ASSEMBLY LH (LAP BELT ANCHOR)	73220	-	-	-
31	FRONT SEAT OUTER BELT ASSEMBLY RH (LAP BELT ANCHOR)	73210	-	-	-

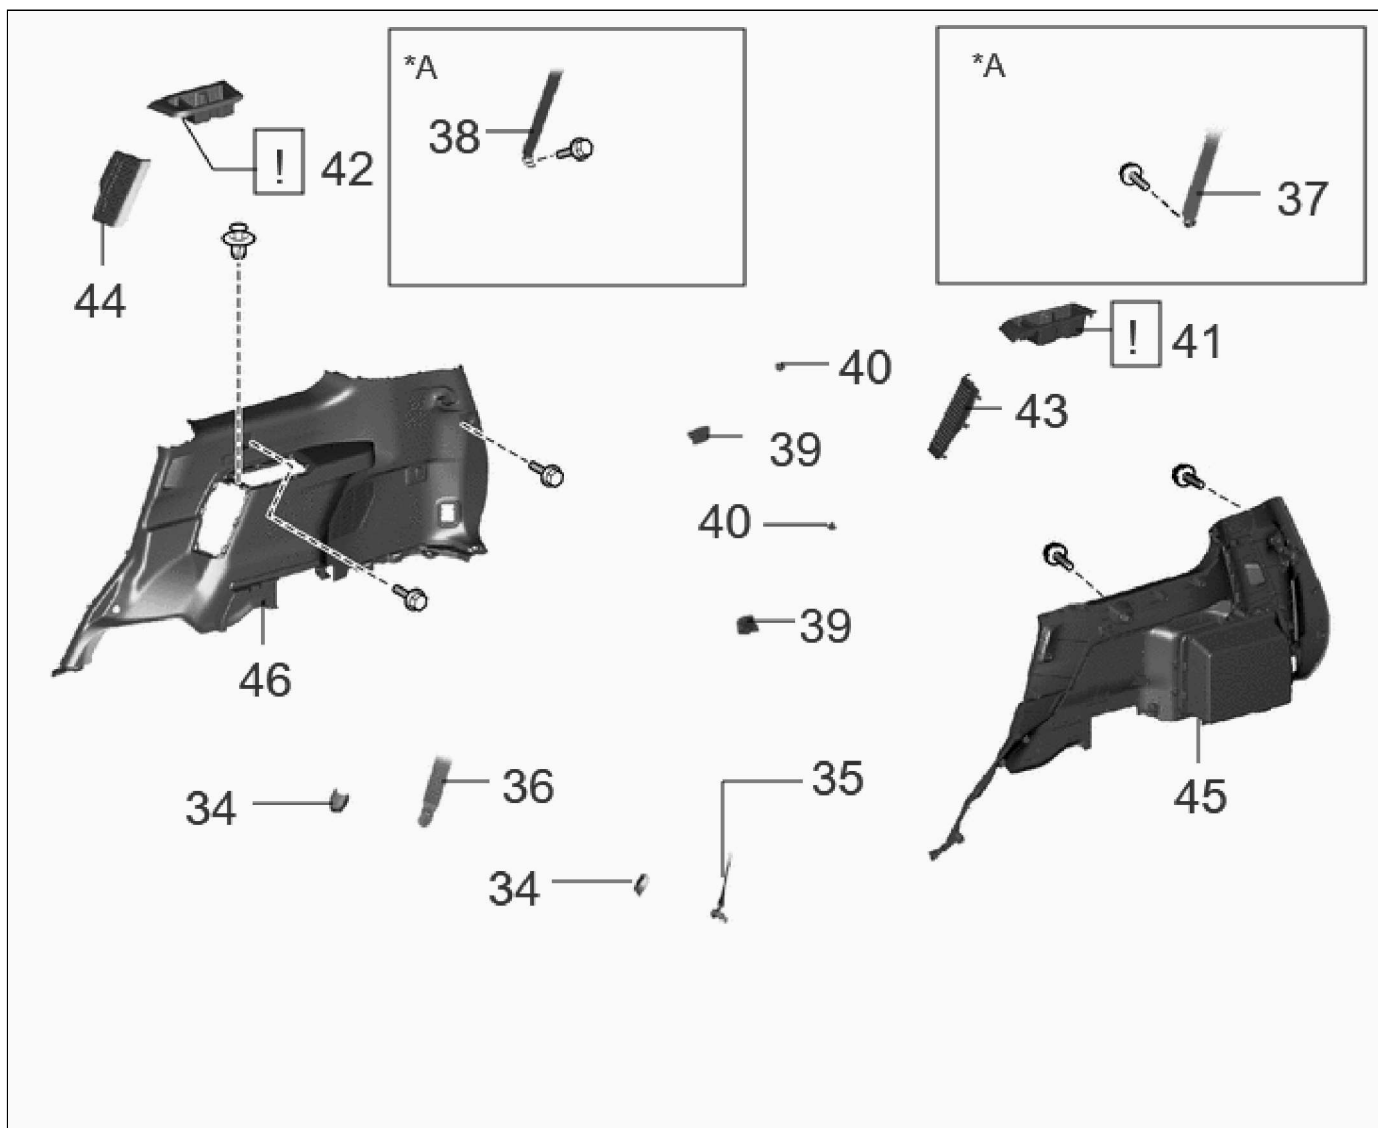
32	CENTER PILLAR LOWER GARNISH LH	62414A	-	-	-
33	CENTER PILLAR LOWER GARNISH RH	62413A	-	-	-

34	OUTER LAP BELT ANCHOR COVER	73233	-	-	-
35	REAR NO. 1 SEAT OUTER BELT ASSEMBLY LH (LAP BELT ANCHOR)	73370E	-	-	-
36	REAR NO. 1 SEAT OUTER BELT ASSEMBLY RH (LAP BELT ANCHOR)	73360D	-	-	-

37	REAR NO. 2 SEAT OUTER BELT ASSEMBLY LH (LAP BELT ANCHOR)	73570	-	-	-
38	REAR NO. 2 SEAT OUTER BELT ASSEMBLY RH (LAP BELT ANCHOR)	73560	-	-	-
39	NO. 1 TONNEAU COVER HOLDER CAP	64937A	-	-	-
40	NO. 1 LUGGAGE COMPARTMENT TRIM HOOK	64725D	-	-	-
41	NO. 2 CUP HOLDER	66992

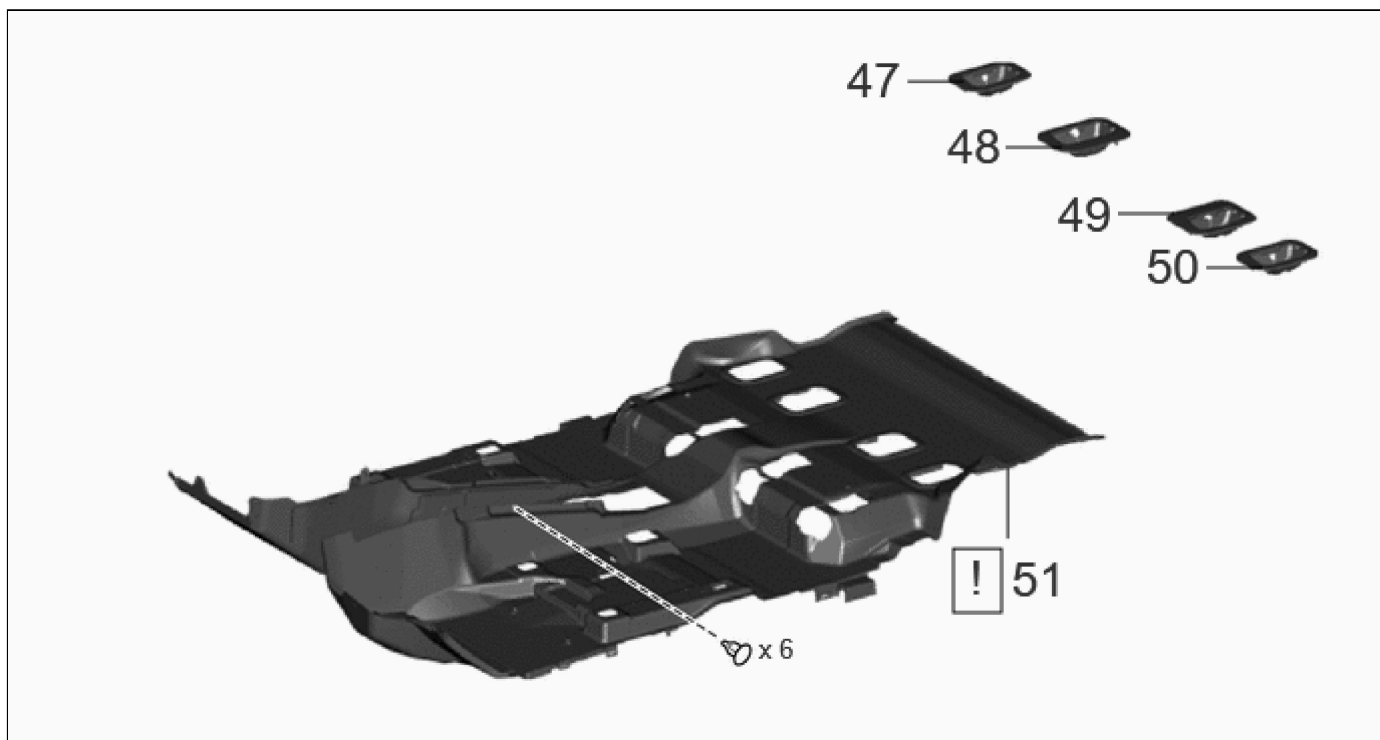
47	REAR NO. 1 SEAT PROTECTOR	71695S	-	-	-

48	REAR NO. 2 SEAT PROTECTOR	71695T	-	-	-
49	REAR NO. 3 SEAT PROTECTOR	71695Y	-	-	-
50	REAR NO. 1 SEAT PROTECTOR	71695S	-	-	-
51	FRONT FLOOR CARPET ASSEMBLY	58510D	-	-	-

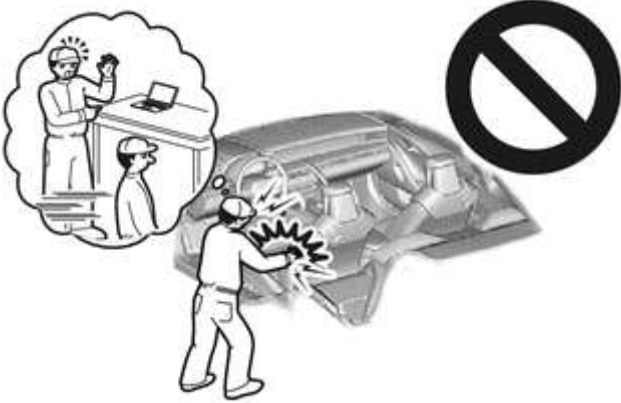
NOTICE:

After turning the ignition switch off, waiting time may be required before disconnecting the cable from the negative (-) auxiliary battery terminal.

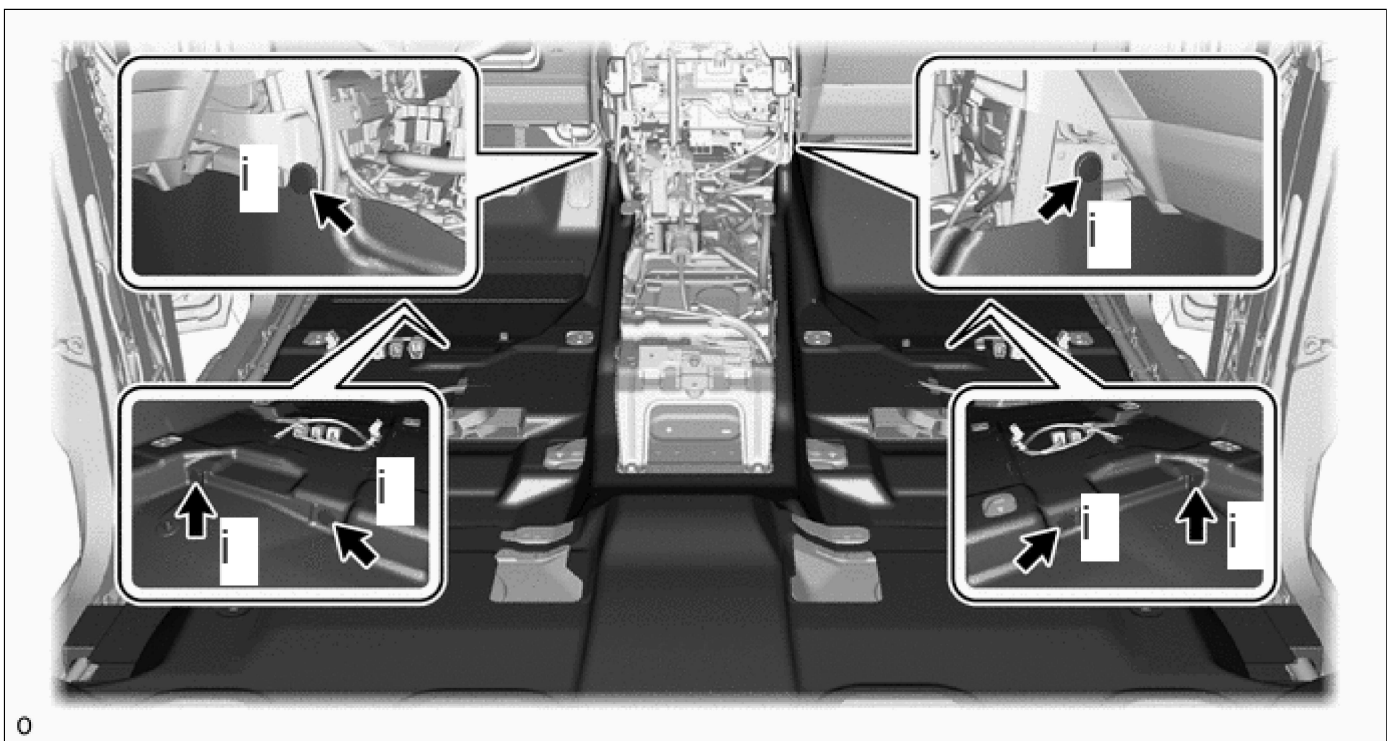
51. REMOVE FRONT FLOOR CARPET ASSEMBLY

(1) Remove the 6 clips.

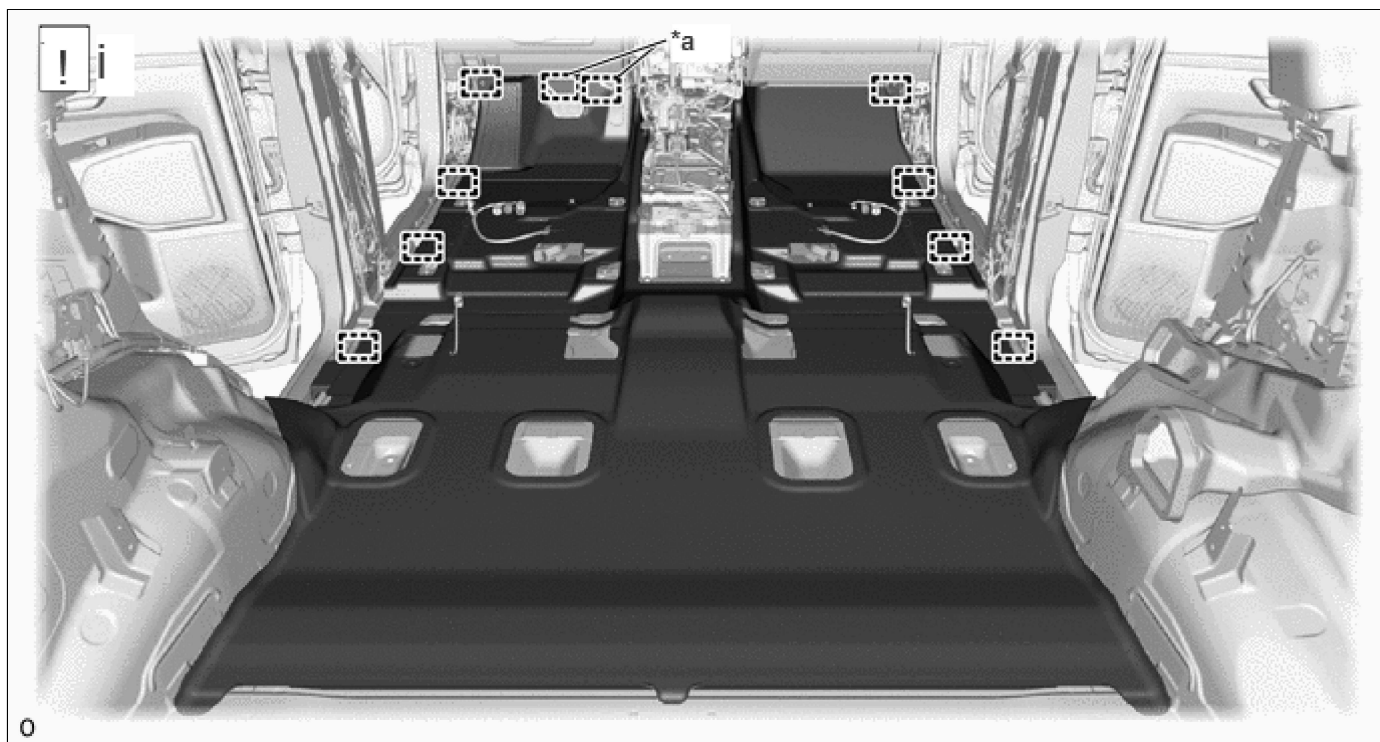
*a	Fastener	-	-
----	----------	---	---

(1) Detach the fasteners and guides to remove the front floor carpet assembly.

Do not pull the slit part of the front floor carpet assembly strongly because there is a risk of damage.
