Last Modified: 07-05-2024	6.11:8.1.0	Doc ID: RM100000002JQ90
Model Year Start: 2024	Model: Land Cruiser	Prod Date Range: [02/2024 -]
Title: INTERIOR PANELS / TRIM: FRONT CONSOLE BOX (w/o Cool Box): REMOVAL; 2024 MY Land Cruiser [02/2024 -]

REMOVAL

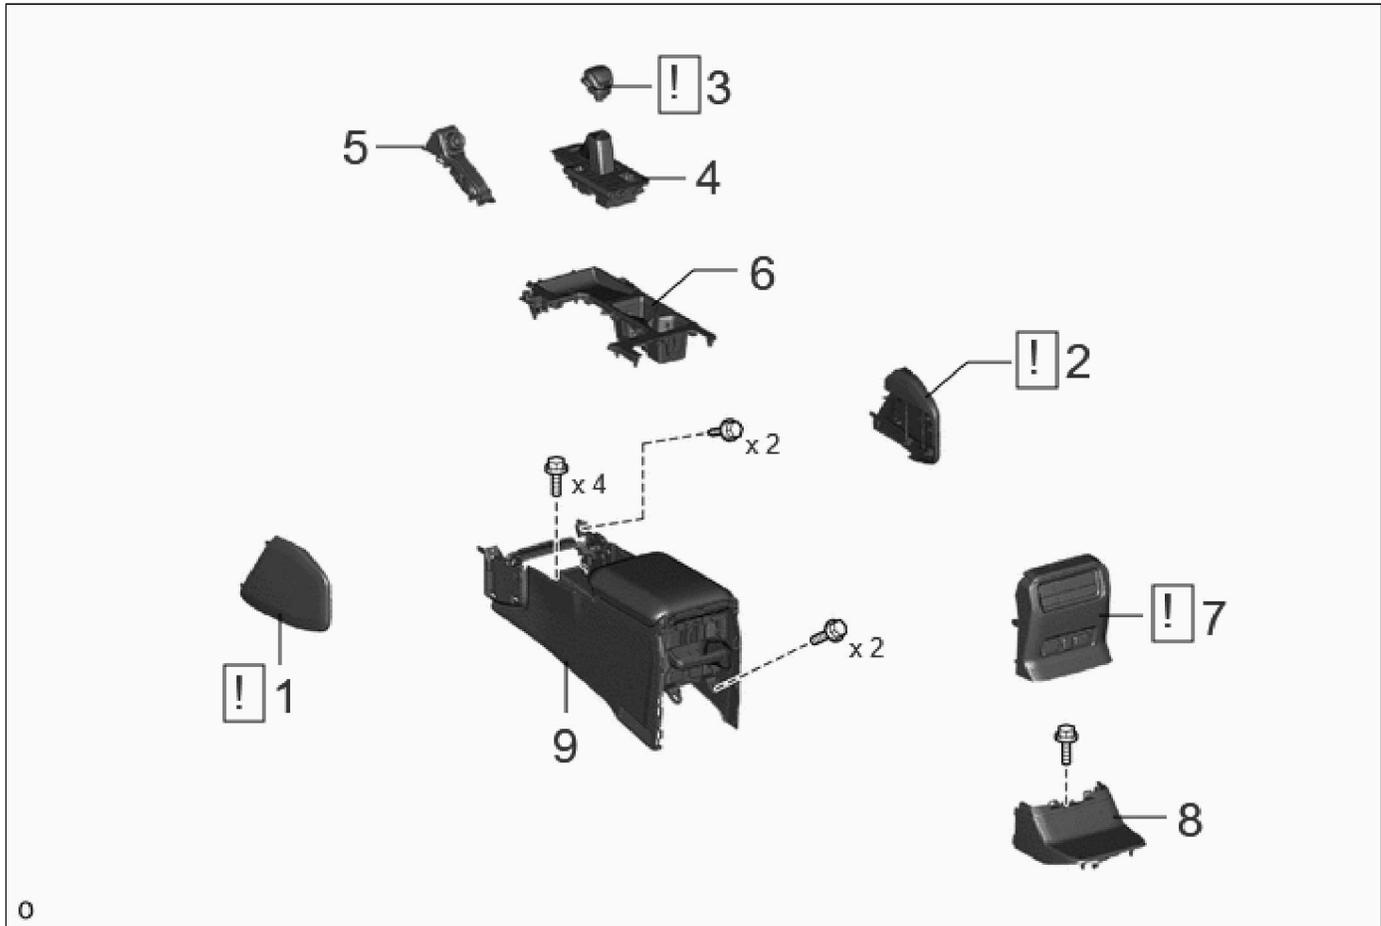
COMPONENTS (REMOVAL)

1	LOWER NO. 1 INSTRUMENT PANEL PAD SUB-ASSEMBLY	55402E	WFO	-	-
2	LOWER NO. 2 INSTRUMENT PANEL PAD SUB-ASSEMBLY	55403G	WFO	-	-
3	SHIFT LEVER KNOB SUB-ASSEMBLY	33504F	WFO	-	-
4	UPPER CONSOLE PANEL ASSEMBLY	-	-	-	-
5	INTEGRATION CONTROL AND PANEL SUB-ASSEMBLY	84012	-	-	-
6	UPPER CONSOLE PANEL SUB-ASSEMBLY	58804A	-	-	-

7	CONSOLE REAR END PANEL SUB-ASSEMBLY	58903A

-	-
8	NO. 2 CONSOLE REAR END PANEL SUB-ASSEMBLY	58904C	-	-	-
9	CONSOLE BOX ASSEMBLY	-	-	-	-

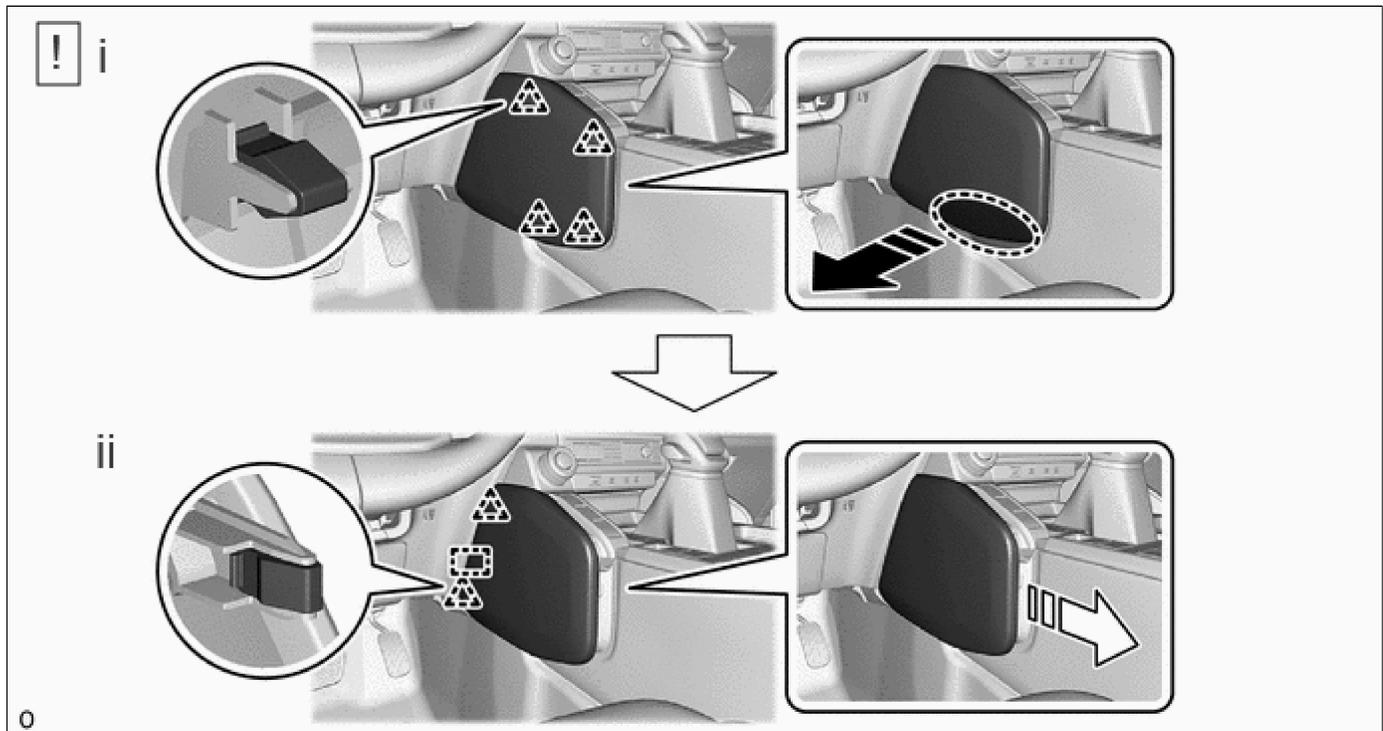
1. REMOVE LOWER NO. 1 INSTRUMENT PANEL PAD SUB-ASSEMBLY

(1) Place your hand as shown in the illustration, detach the clip.

(2) Detach the clip and guide and remove the lower No. 1 instrument panel pad sub-assembly.

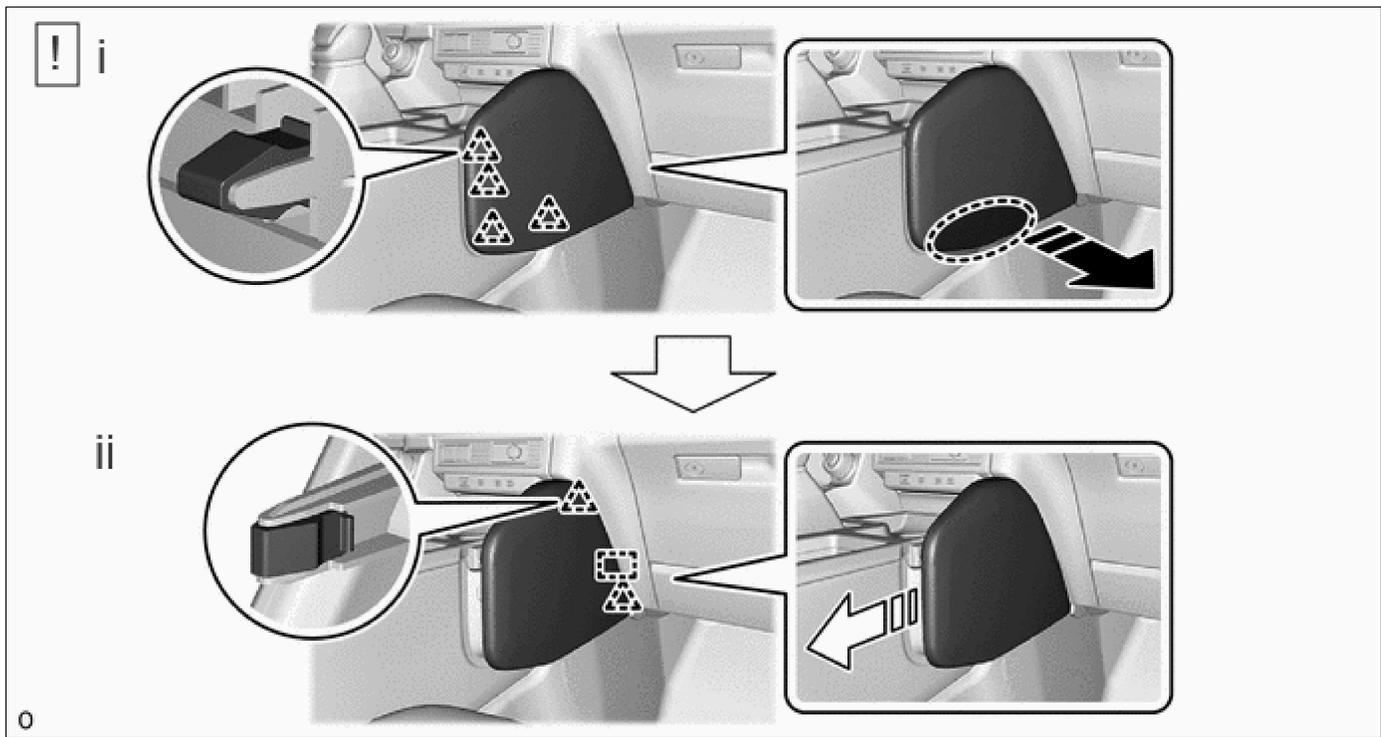
2. REMOVE LOWER NO. 2 INSTRUMENT PANEL PAD SUB-ASSEMBLY

(1) Place your hand as shown in the illustration, detach the clip.

(2) Detach the clip and guide and remove the lower No. 2 instrument panel pad sub-assembly.

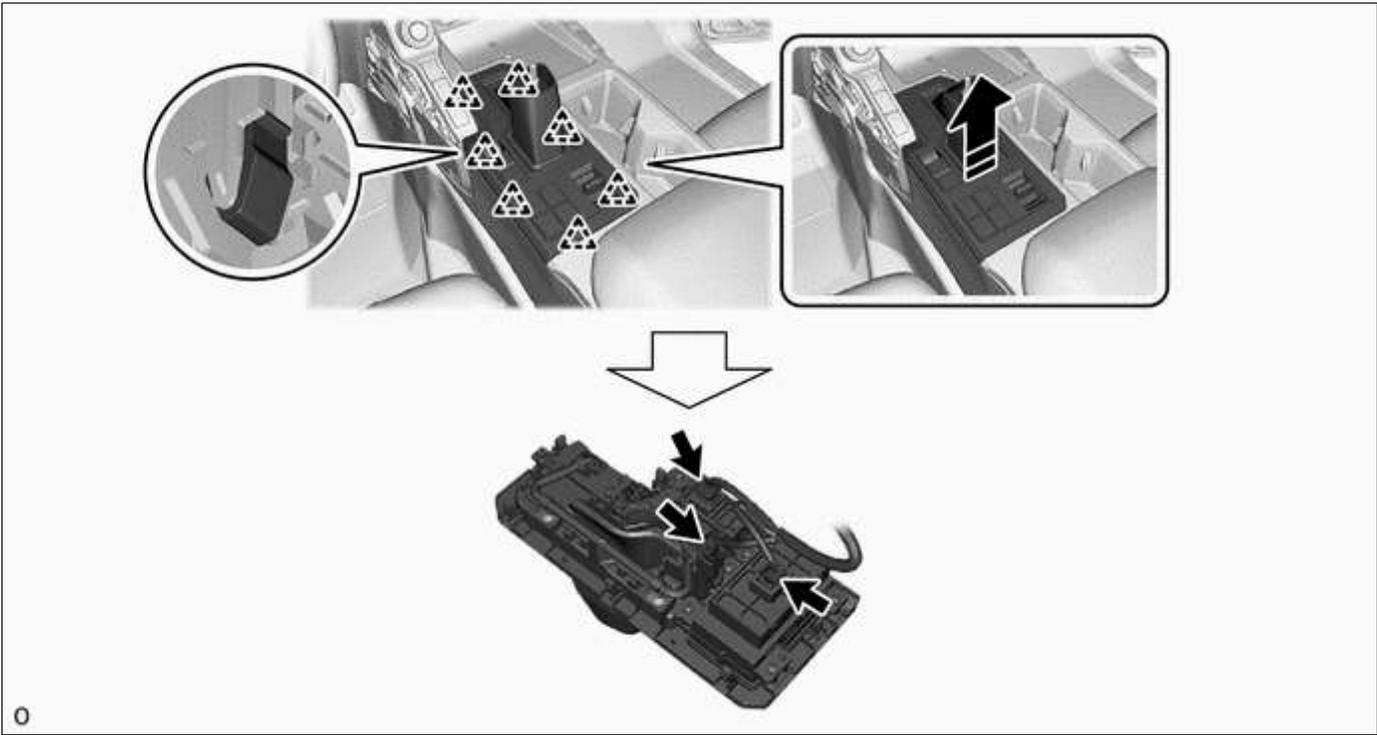
4. REMOVE UPPER CONSOLE PANEL ASSEMBLY

Remove in this Direction	-	-
---	--------------------------	---	---

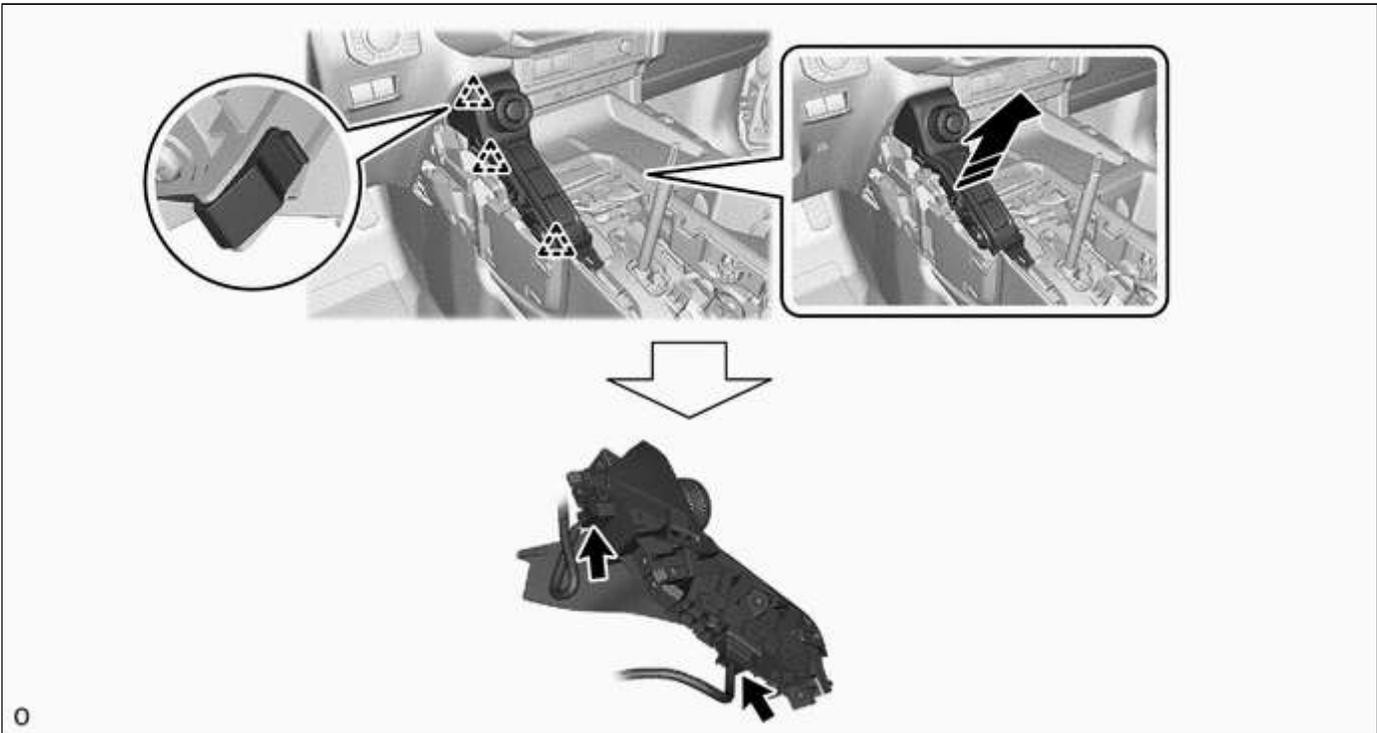
5. REMOVE INTEGRATION CONTROL AND PANEL SUB-ASSEMBLY

Remove in this Direction	-	-
---	--------------------------	---	---

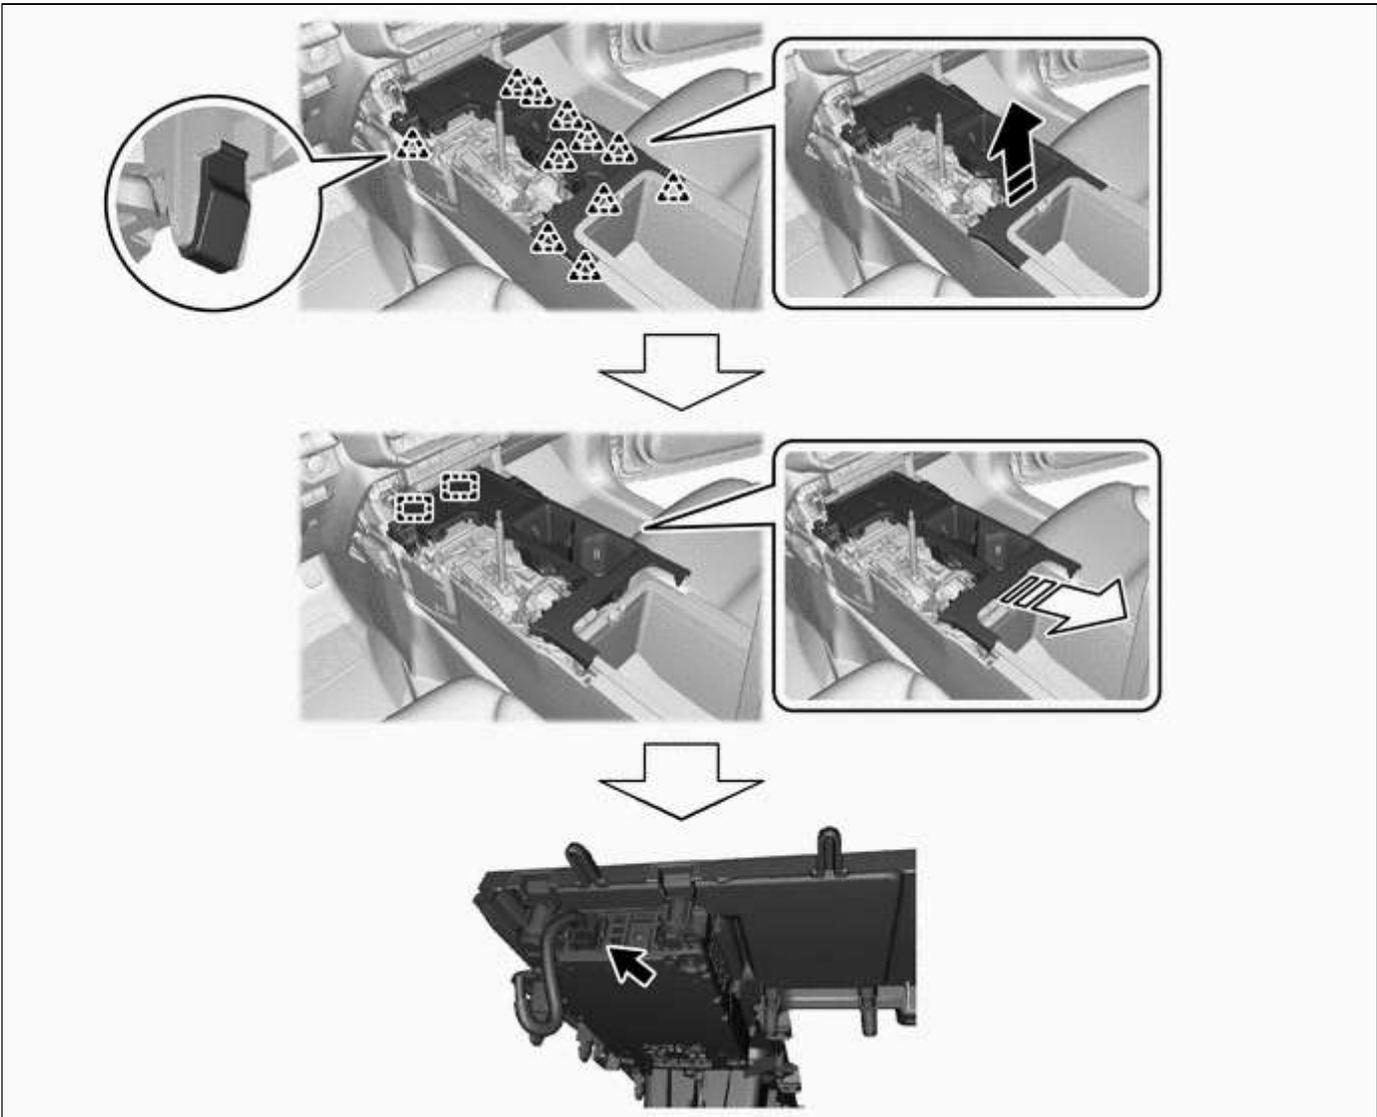
6. REMOVE UPPER CONSOLE PANEL SUB-ASSEMBLY

Remove in this Direction (1)		Remove in this Direction (2)
--	------------------------------	--	------------------------------

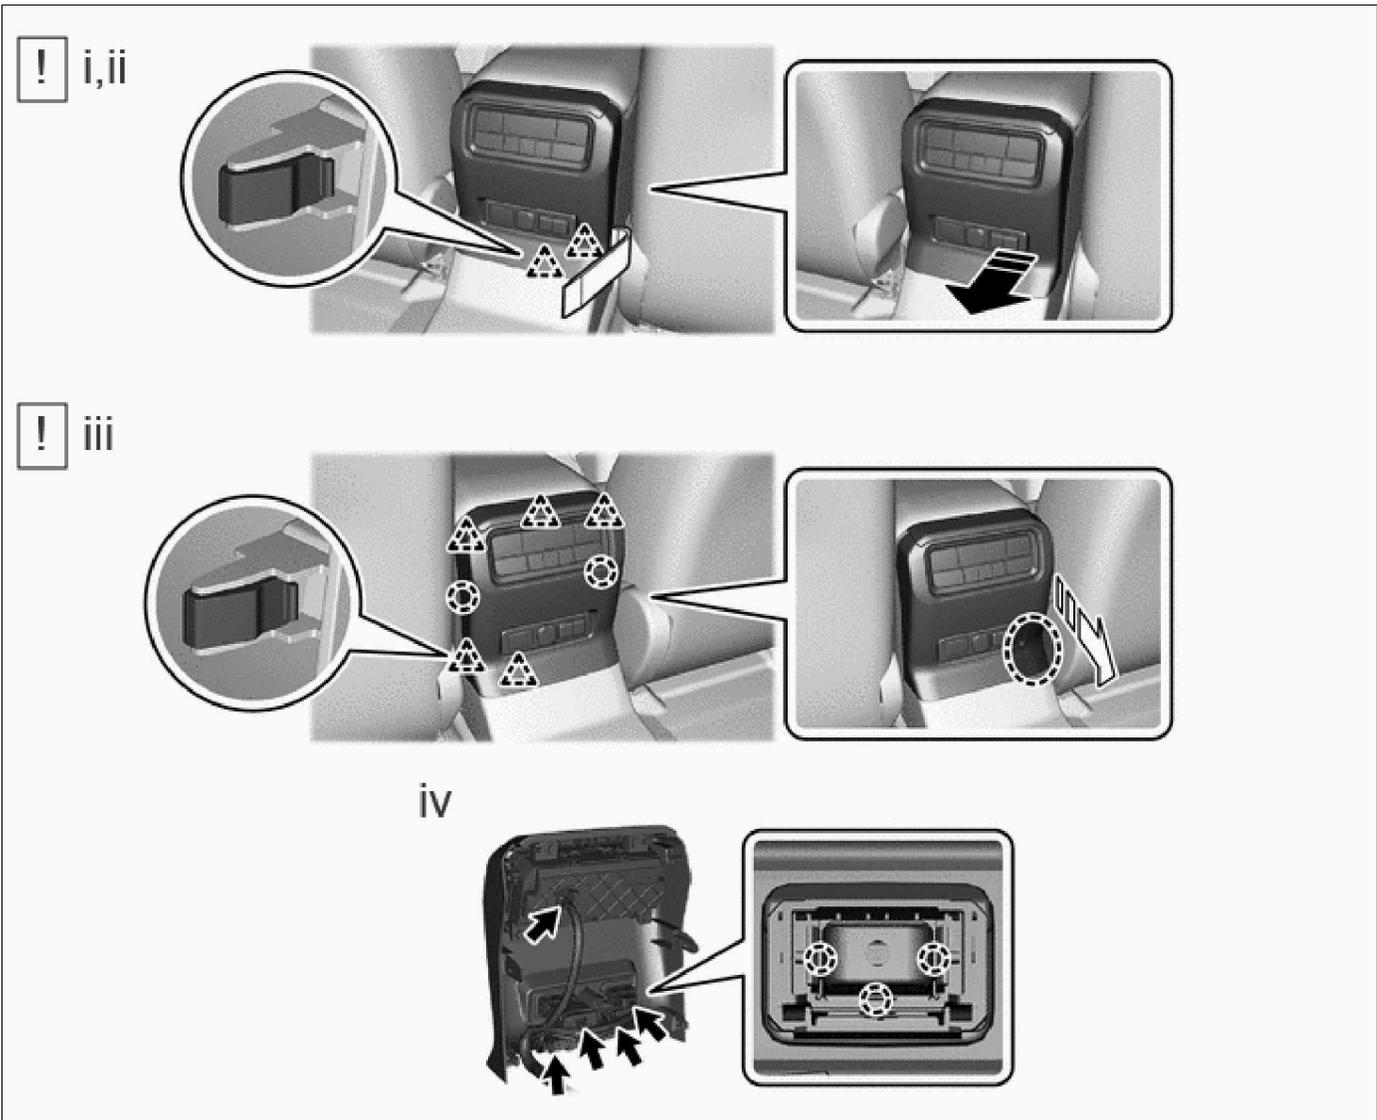
7. REMOVE CONSOLE REAR END PANEL SUB-ASSEMBLY

- (1) Insert moulding remover D in the position shown in the illustration.
- (2) Place your hand in the gap as shown in the illustration, detach the clip.
- (3) Place your hand as shown in the illustration, detach the claw and clip and remove the rear console end panel sub-assembly.
- (4) Disconnect the each connectors and detach the claw.

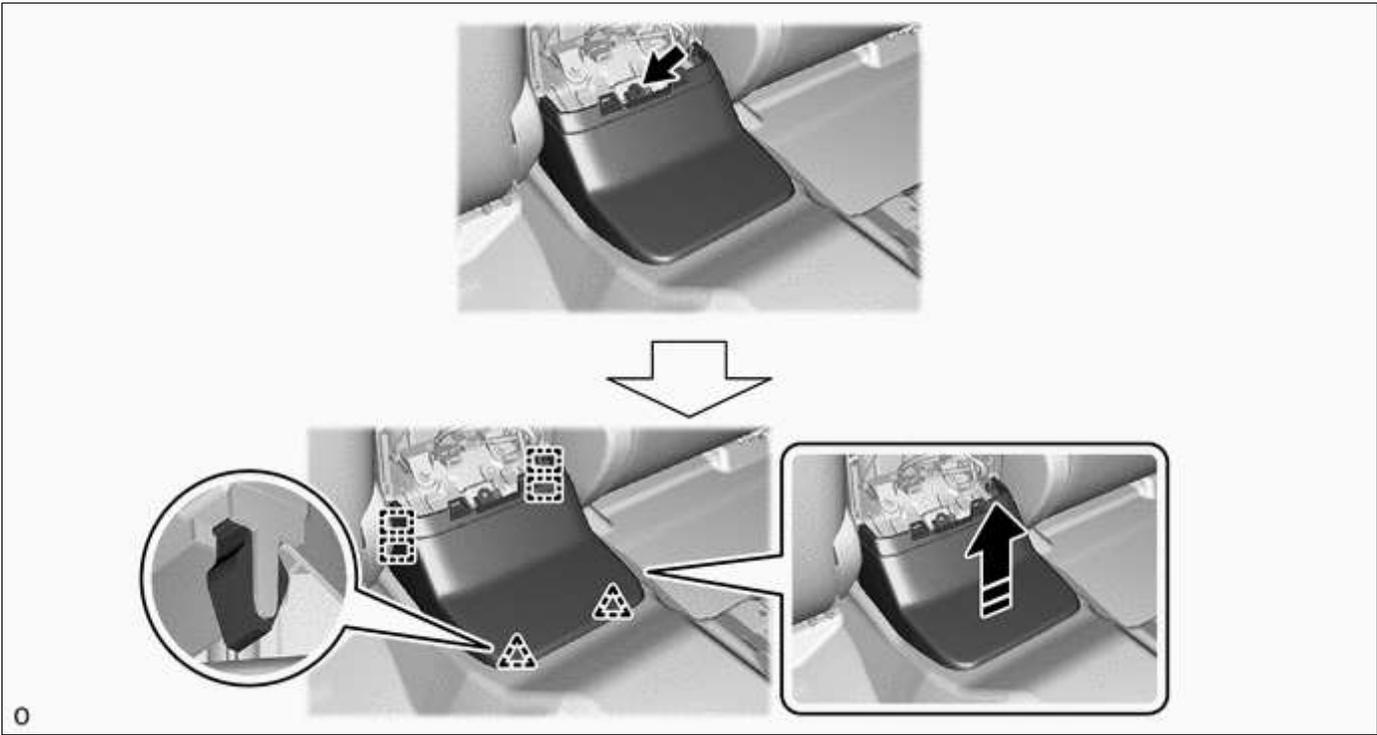
8. REMOVE NO. 2 CONSOLE REAR END PANEL SUB-ASSEMBLY

Remove in this Direction	-	-
---	--------------------------	---	---

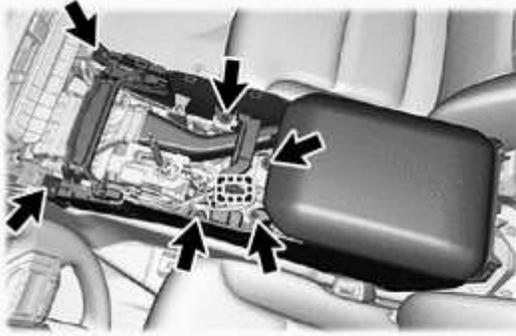
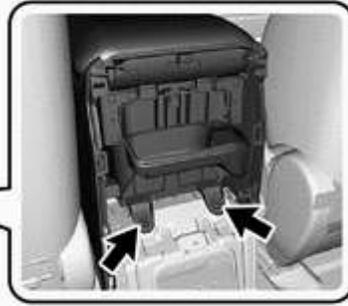
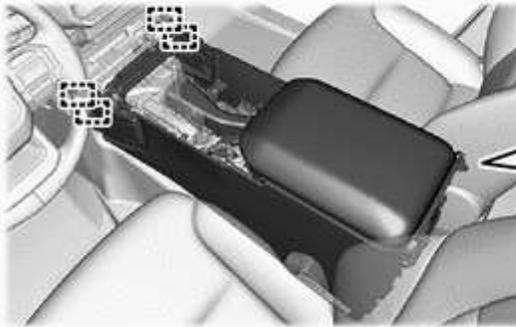
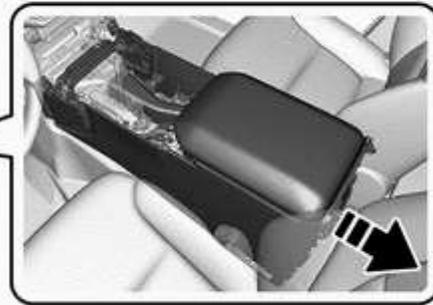
9. REMOVE CONSOLE BOX ASSEMBLY

Remove in this Direction
