Last Modified: 07-05-2024	6.11:8.1.0	Doc ID: RM100000002I8V3
Model Year Start: 2024	Model: Land Cruiser	Prod Date Range: [02/2024 -]
Title: MIRROR (INT): INNER REAR VIEW MIRROR (w/ EC Mirror): REMOVAL; 2024 MY Land Cruiser [02/2024 -]

REMOVAL

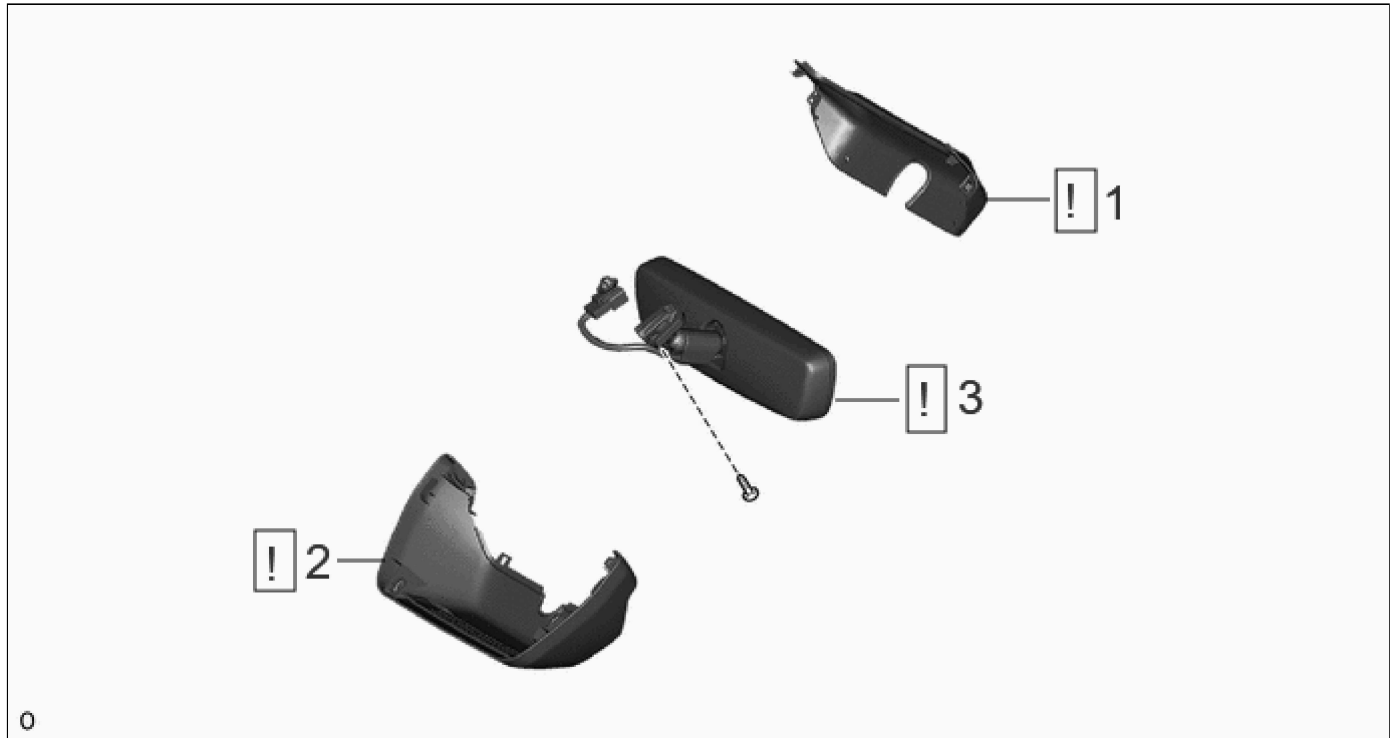
COMPONENTS (REMOVAL)

1	NO. 2 FORWARD RECOGNITION COVER	86466E	INFO	-	-

2	NO. 1 FORWARD RECOGNITION COVER	86466D	INFO	-	-
3	INNER REAR VIEW MIRROR ASSEMBLY	87810	INFO	-	-

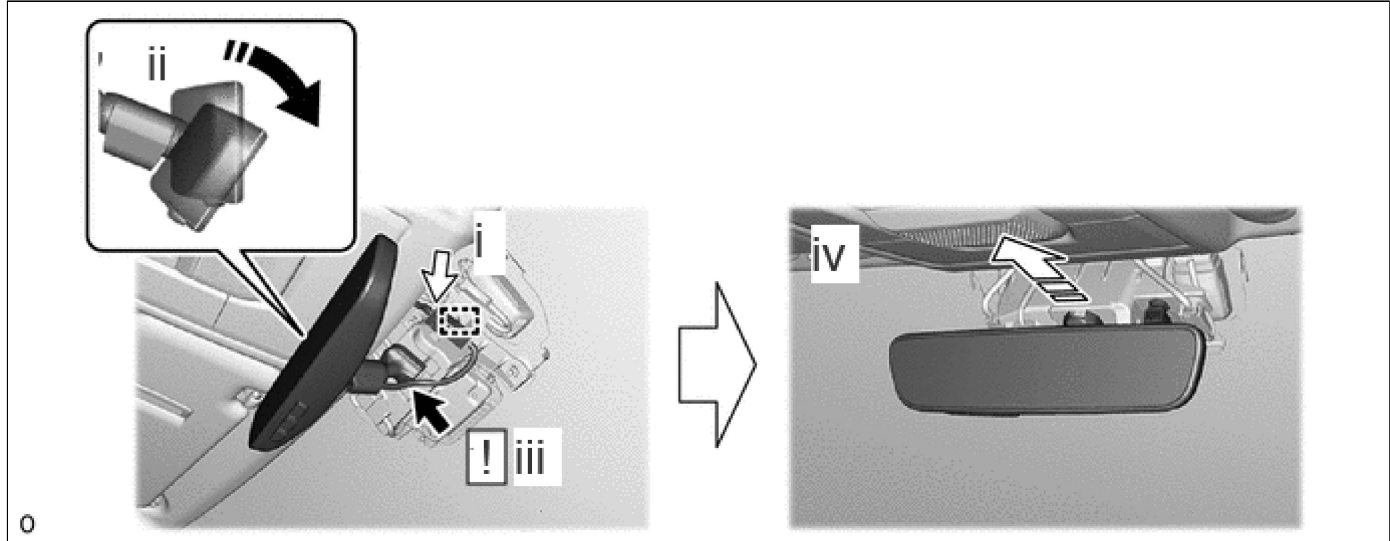
3. REMOVE INNER REAR VIEW MIRROR ASSEMBLY

Tilt in this Direction

Remove in this Direction

Screw

Connector

- (1) Detach the clamp and disconnect the connector.
- (2) Tilt the mirror surface down to the maximum tiltable position.
- (3) Using a T20 "TORX" socket wrench, remove the "TORX" screw.

- (4) Slide the inner rear view mirror assembly as shown in the illustration and remove the inner rear view mirror assembly.
